Karuah Hard Rock Quarry

Environmental Monitoring Report:

April 2022

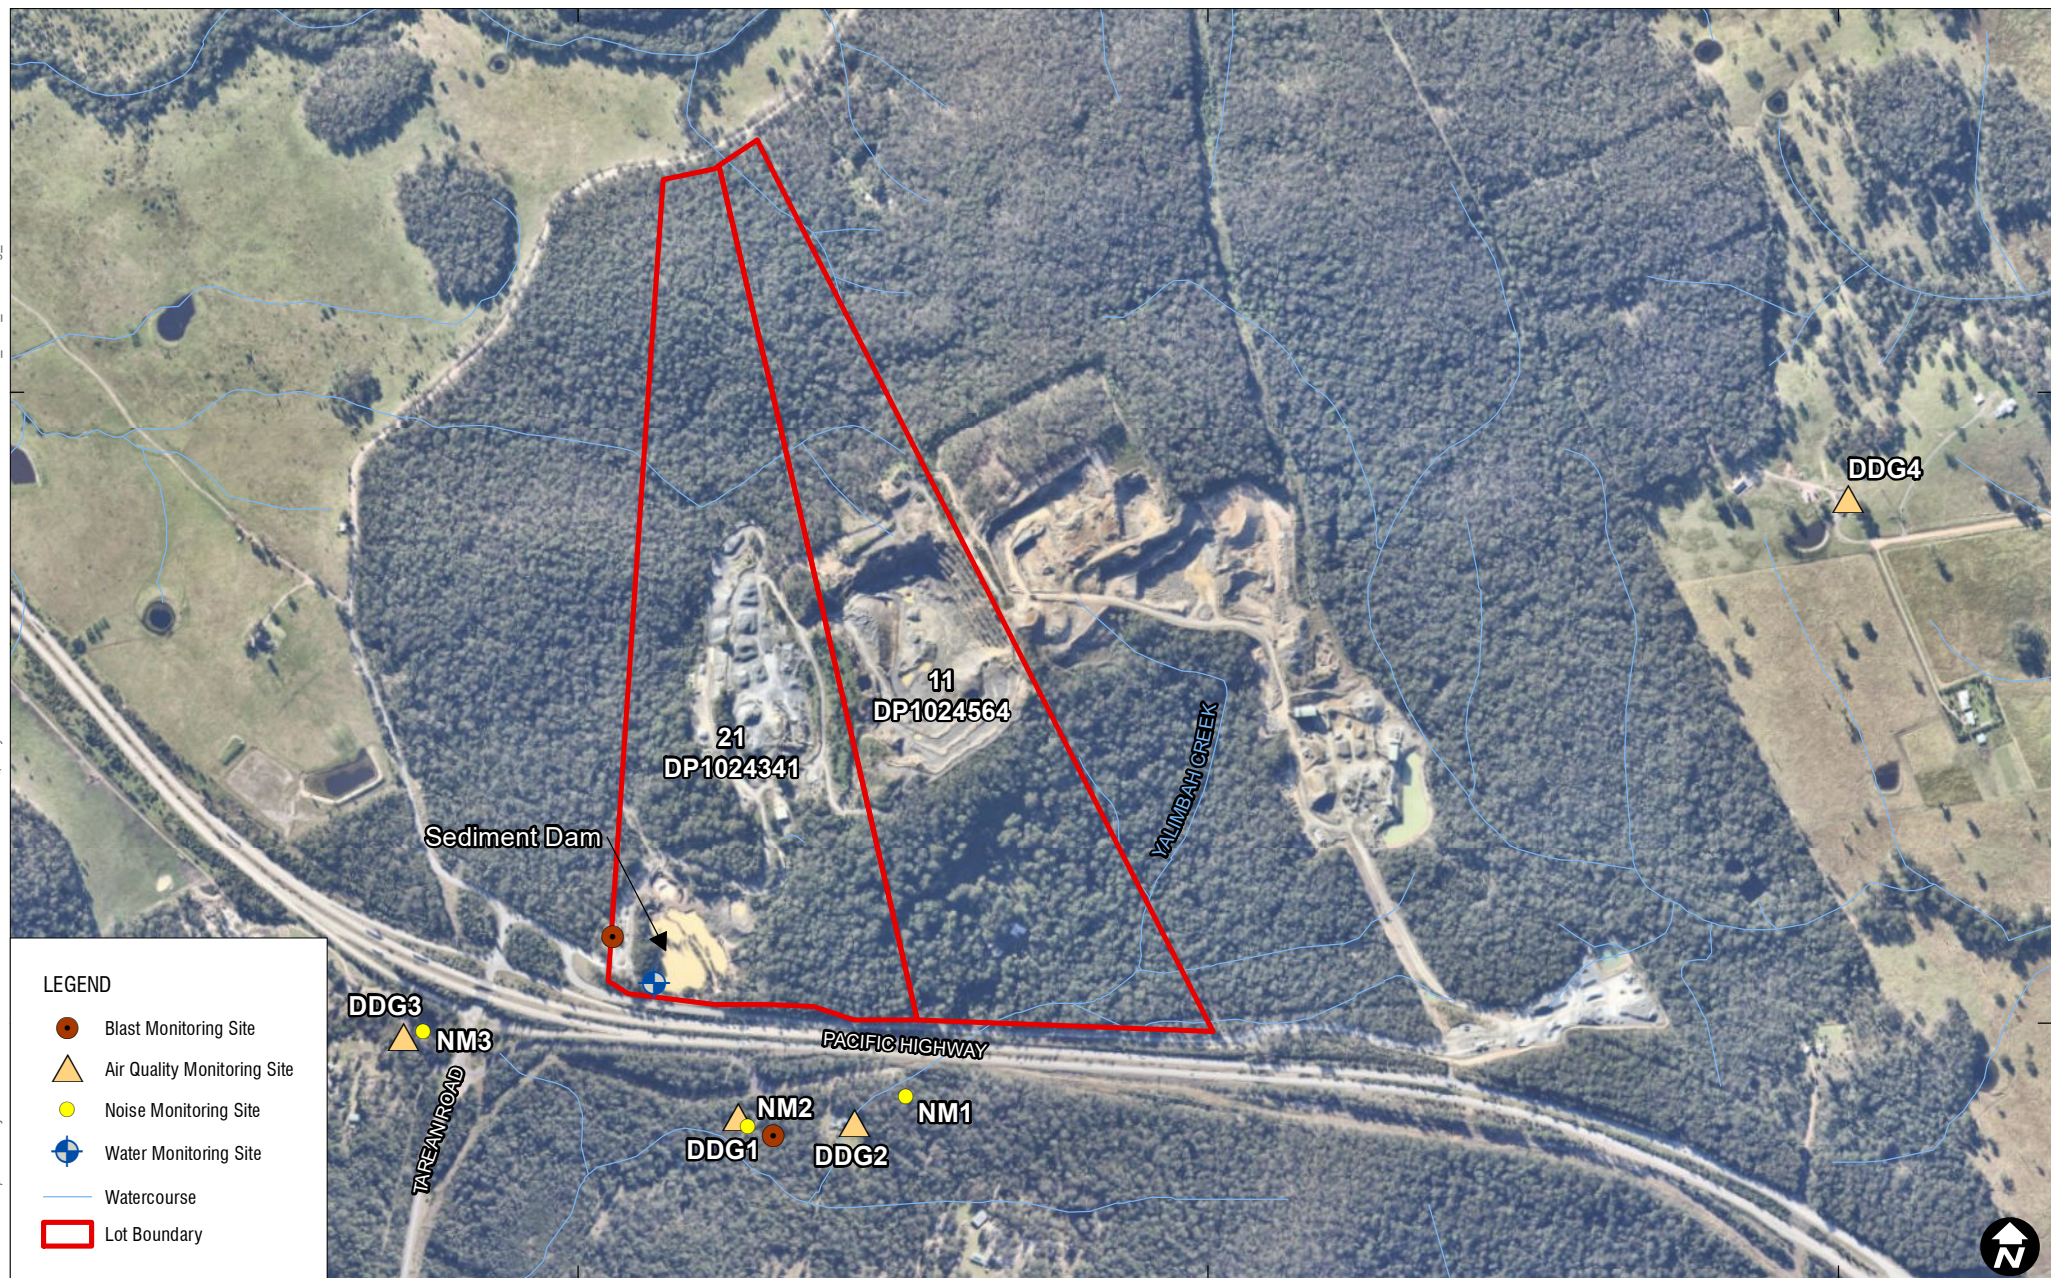
Appendix 1 – Monitoring Locations

Monitoring locations are identified in in Appendix 1.
