Karuah Hard Rock Quarry

Environmental Monitoring Report:

April 2023

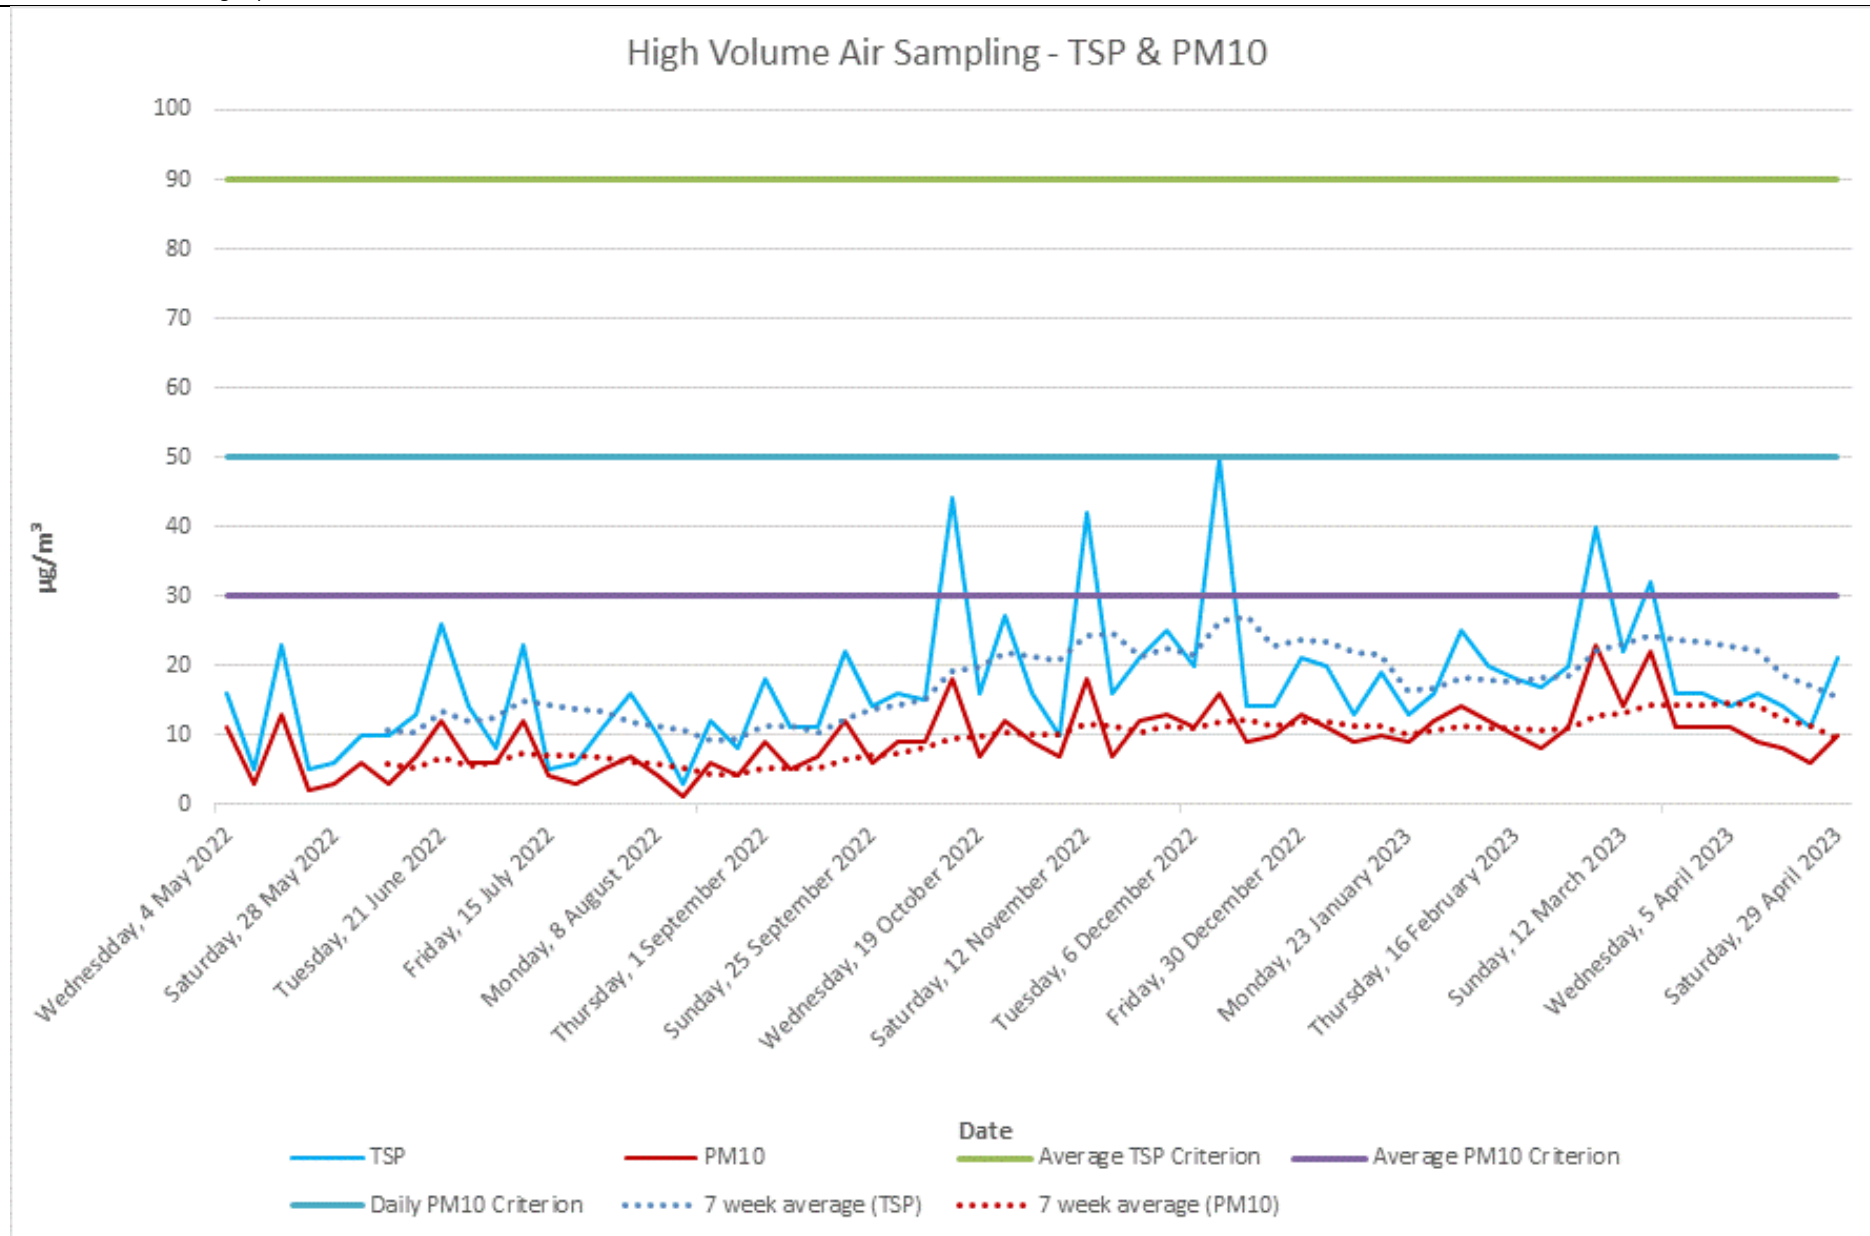
Figure 1 High Volume Air Sampling 2022/2023

All HVAS monitoring results, to the end of April 2023 were compliant with the long term and short term impact assessment criteria outlined in *Schedule 3 Condition 13* of the Consent (see Table 3, Table 4 and Table 5).

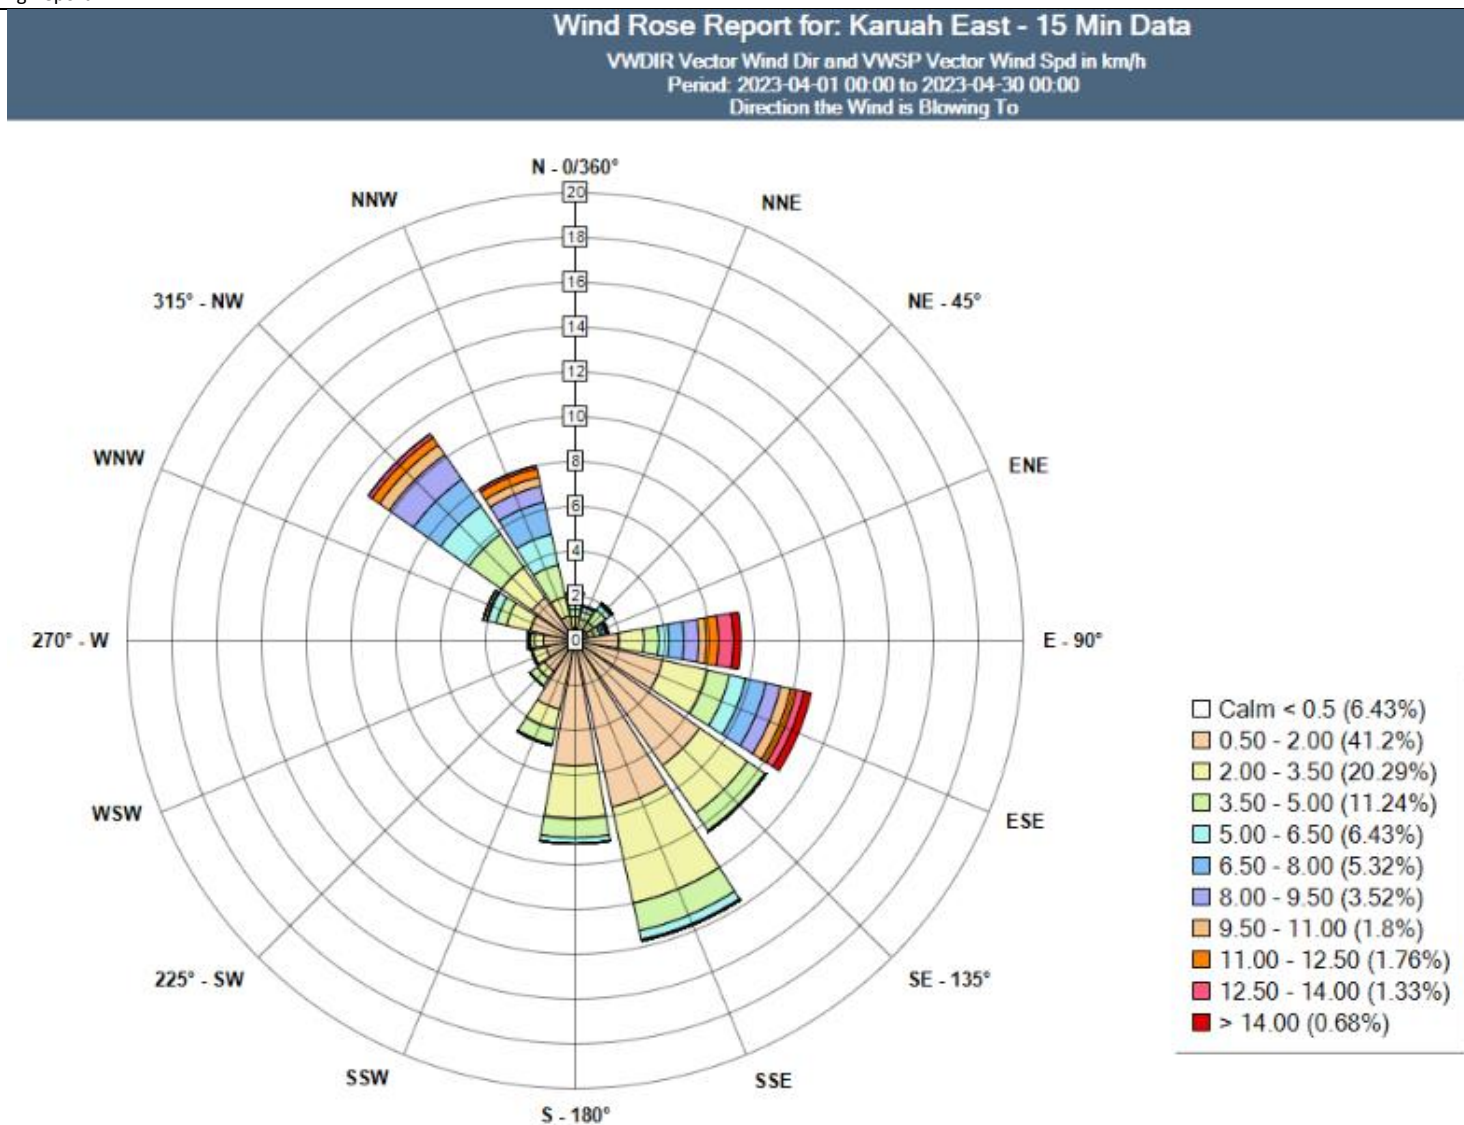
Figure 3 Wind Rose April 2023

A wind rose is a graphic tool used to depict the average direction and speed of the wind over a recorded period. Figure 3 shows the wind rose generated from data gathered during April 2023.
