Karuah East Quarry

# Environmental Monitoring Report

October 2023

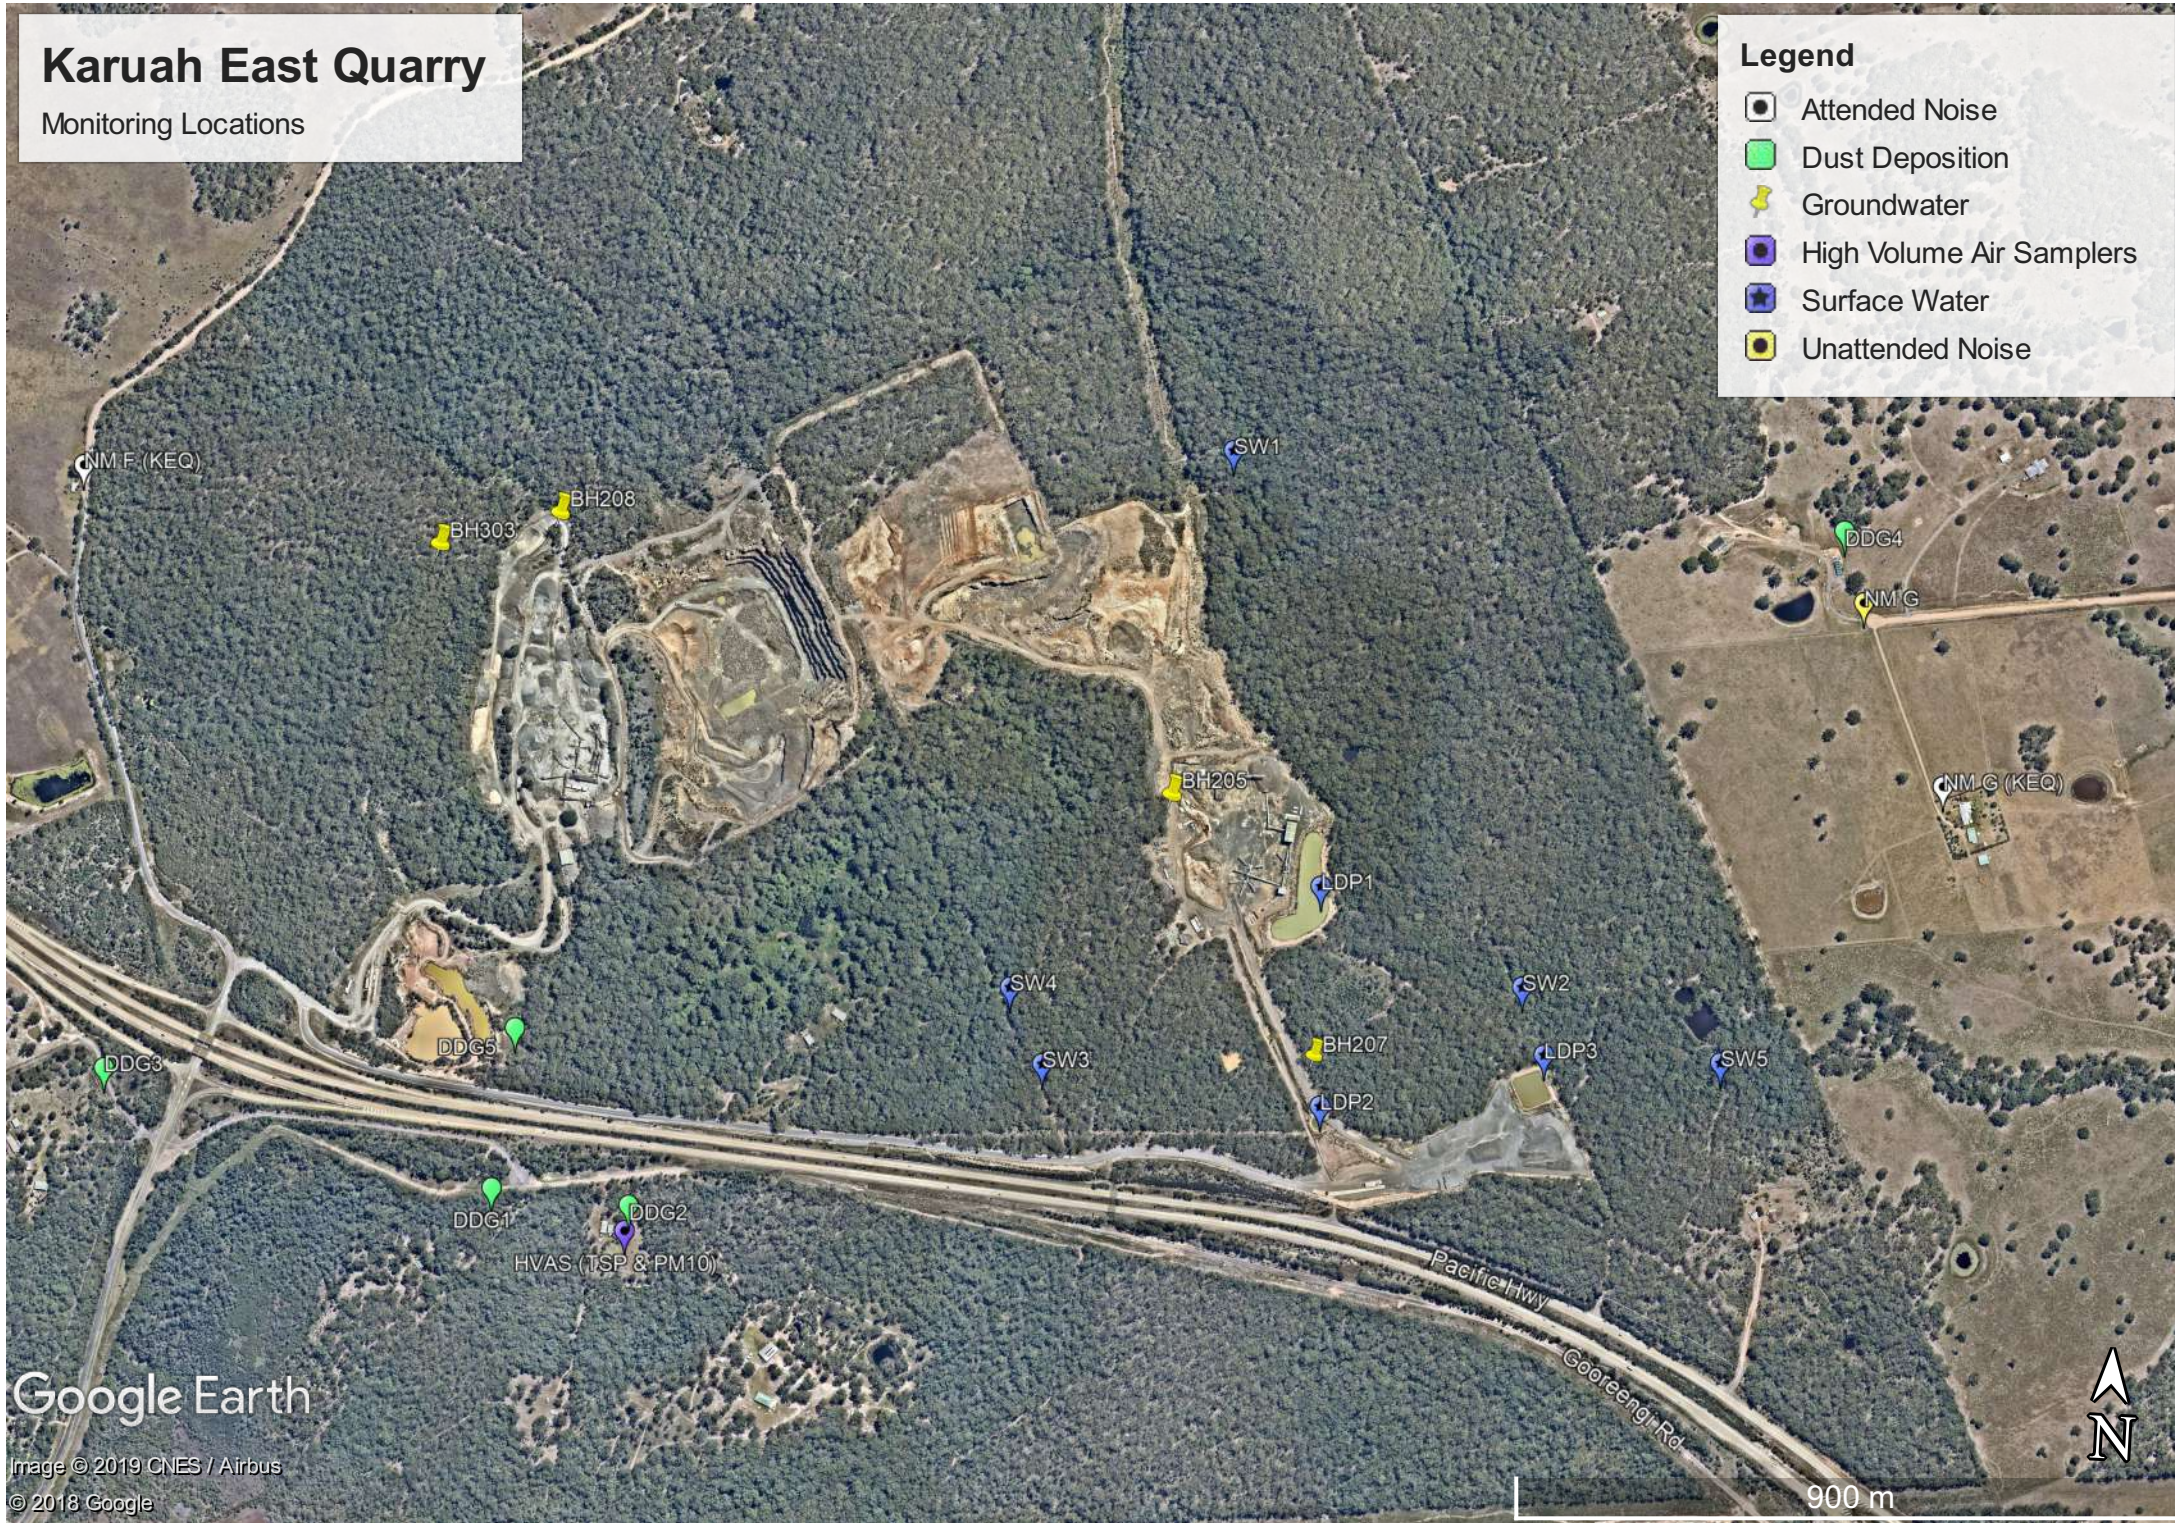
## Appendix 1 – EPL 20611 Monitoring Locations

Monitoring Locations

- Attended Noise
- Dust Deposition
- Groundwater
- High Volume Air Samplers
- Surface Water
- Unattended Noise

Monitoring locations are illustrated by the site plan provided by **Appendix 1**.
