Karuah East Quarry

Environmental Monitoring Report

March 2024

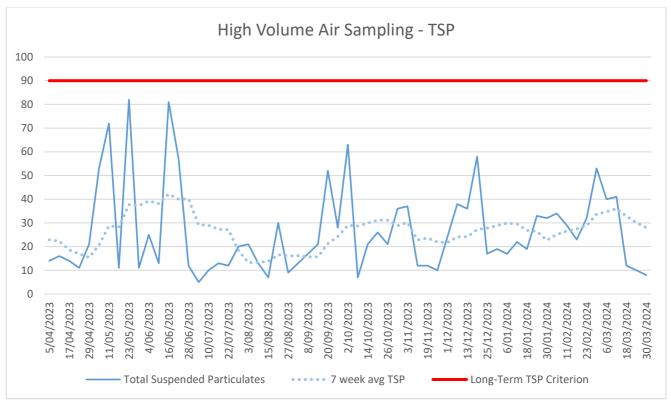
Figure 1 Long-term TSP monitoring trends.

TSP and PM10 results for the Reporting Period are summarised by **Table 8** and illustrated respectively by **Figure 1** and **Figure 2**.

Monitoring results for the five HVAS run days within the Reporting Period were compliant with the long-term limits for TSP and PM10 and short-term limits for PM10.

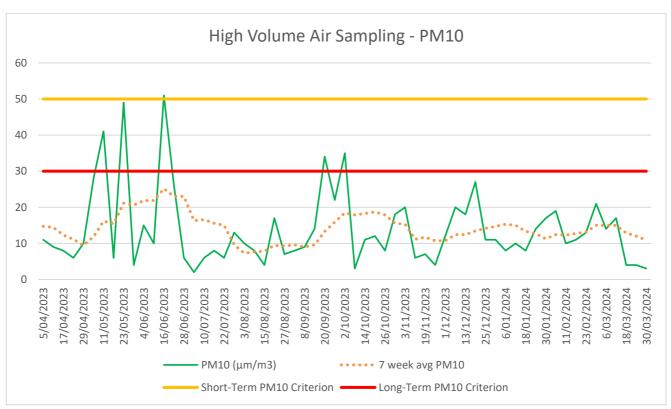
Figure 2 Long-term PM10 monitoring trends.
