Karuah East Quarry

Environmental Monitoring Report

June 2024

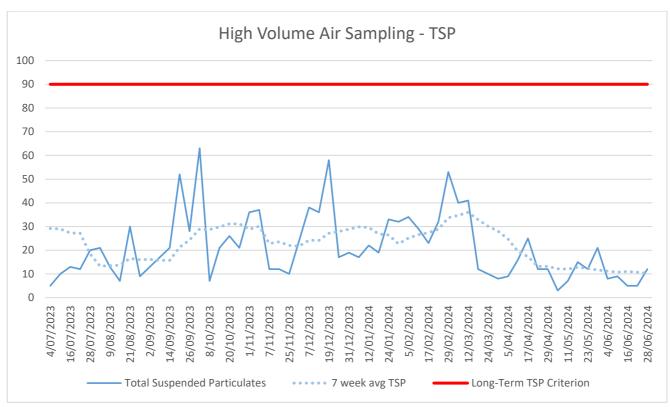
Figure 1 Long-term TSP monitoring trends.

TSP and PM10 results for the Reporting Period are summarised by **Table 8** and illustrated respectively by **Figure 1** and **Figure 2**.

Monitoring results for the five HVAS run days within the Reporting Period were compliant with the long-term limits for TSP and PM10 and short-term limits for PM10.

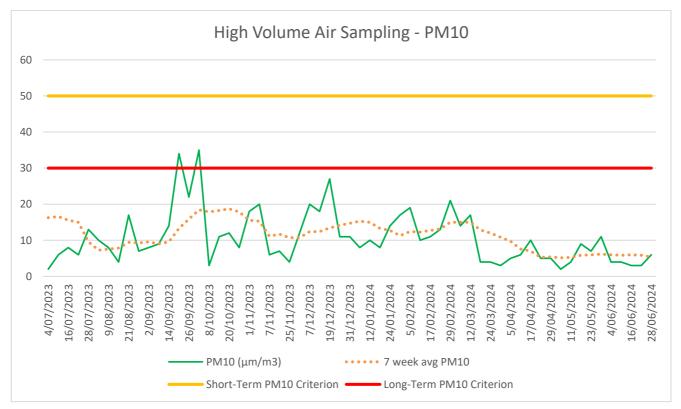
Figure 2 Long-term PM10 monitoring trends.

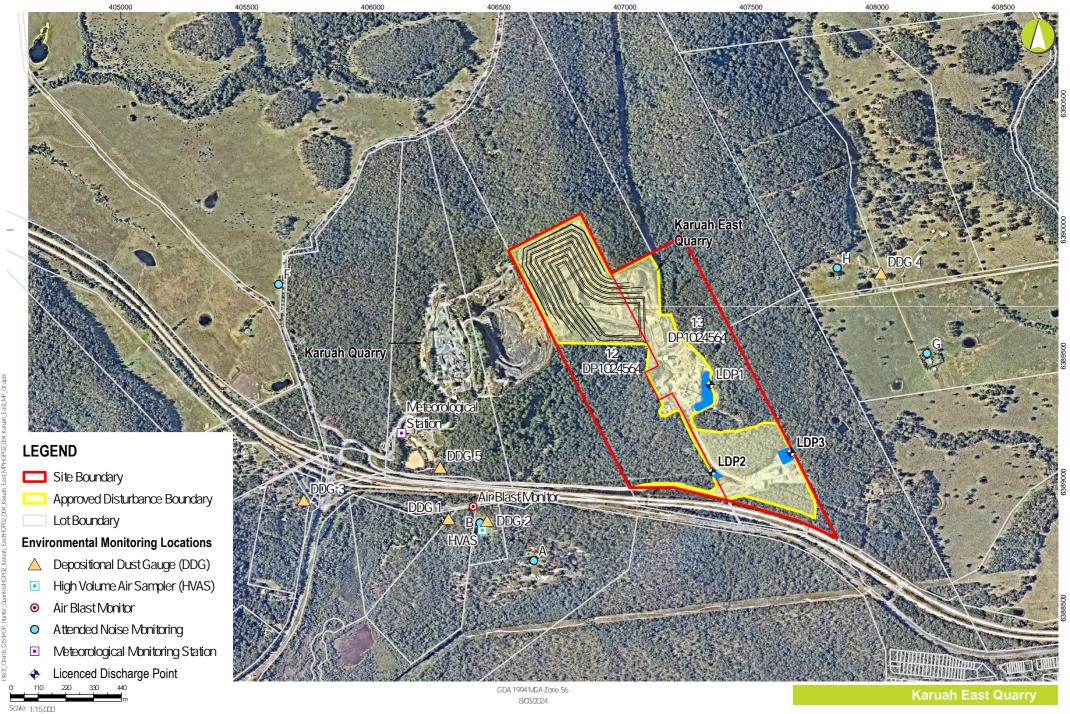
Appendix 1 – EPL 20611 Monitoring Locations

Environmental Monitoring Report
APPENDIX 1 - Environmental Monitoring Locations

Monitoring locations are illustrated by the site plan provided by **Appendix 1**.
