Karuah East Quarry

Environmental Monitoring Report

September 2024

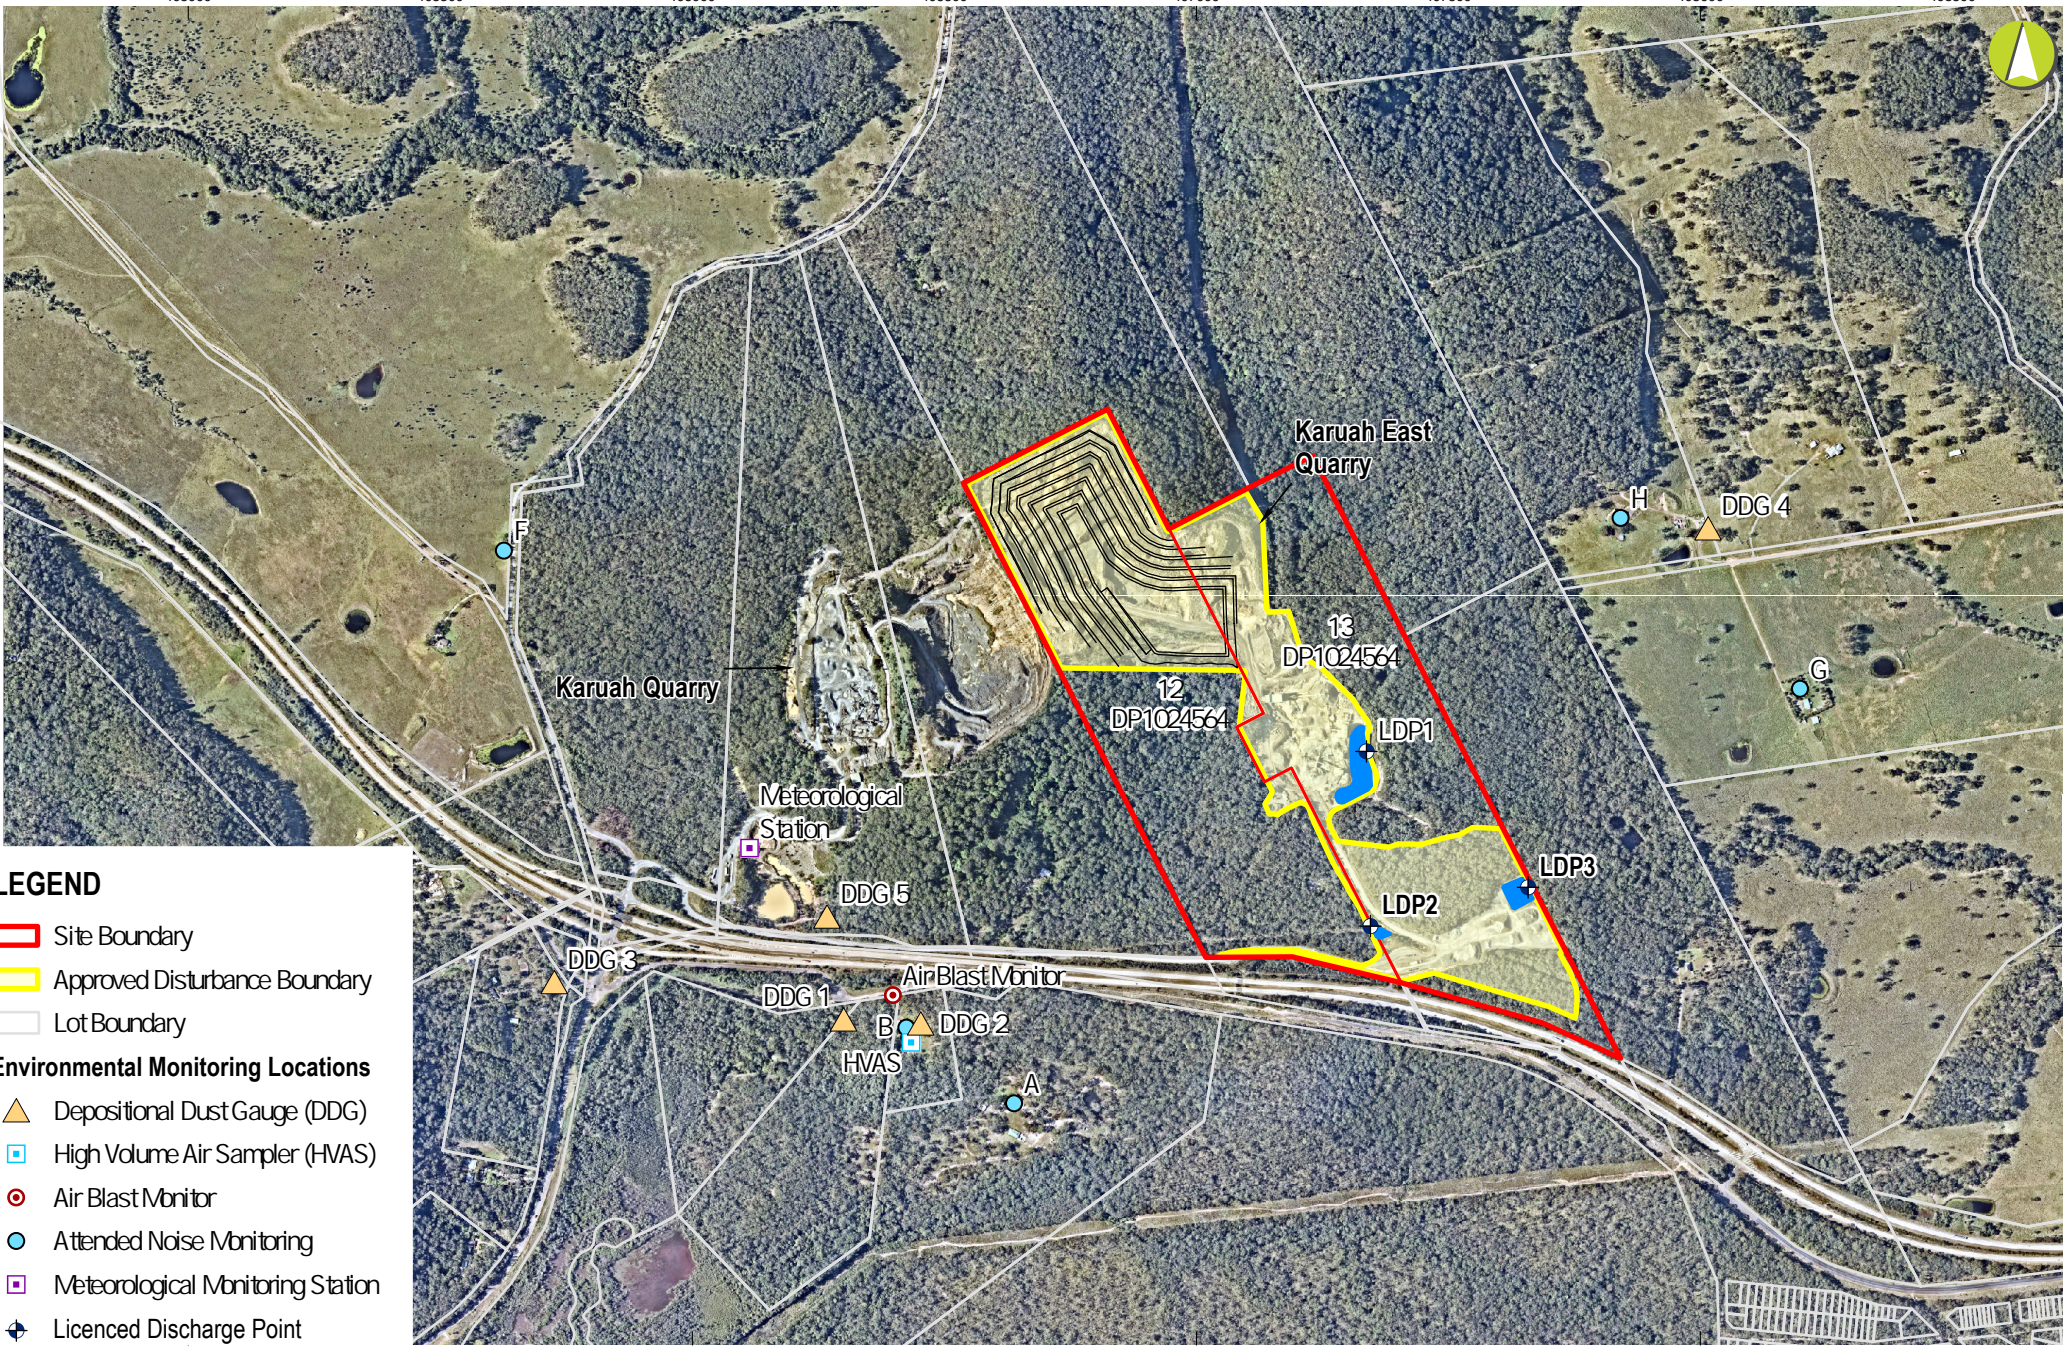
APPENDIX 1 - Environmental Monitoring Locations

Monitoring locations are illustrated by the site plan provided by **Appendix 1**.
