Karuah Hard Rock Quarry

Environmental Monitoring Report

October 2024

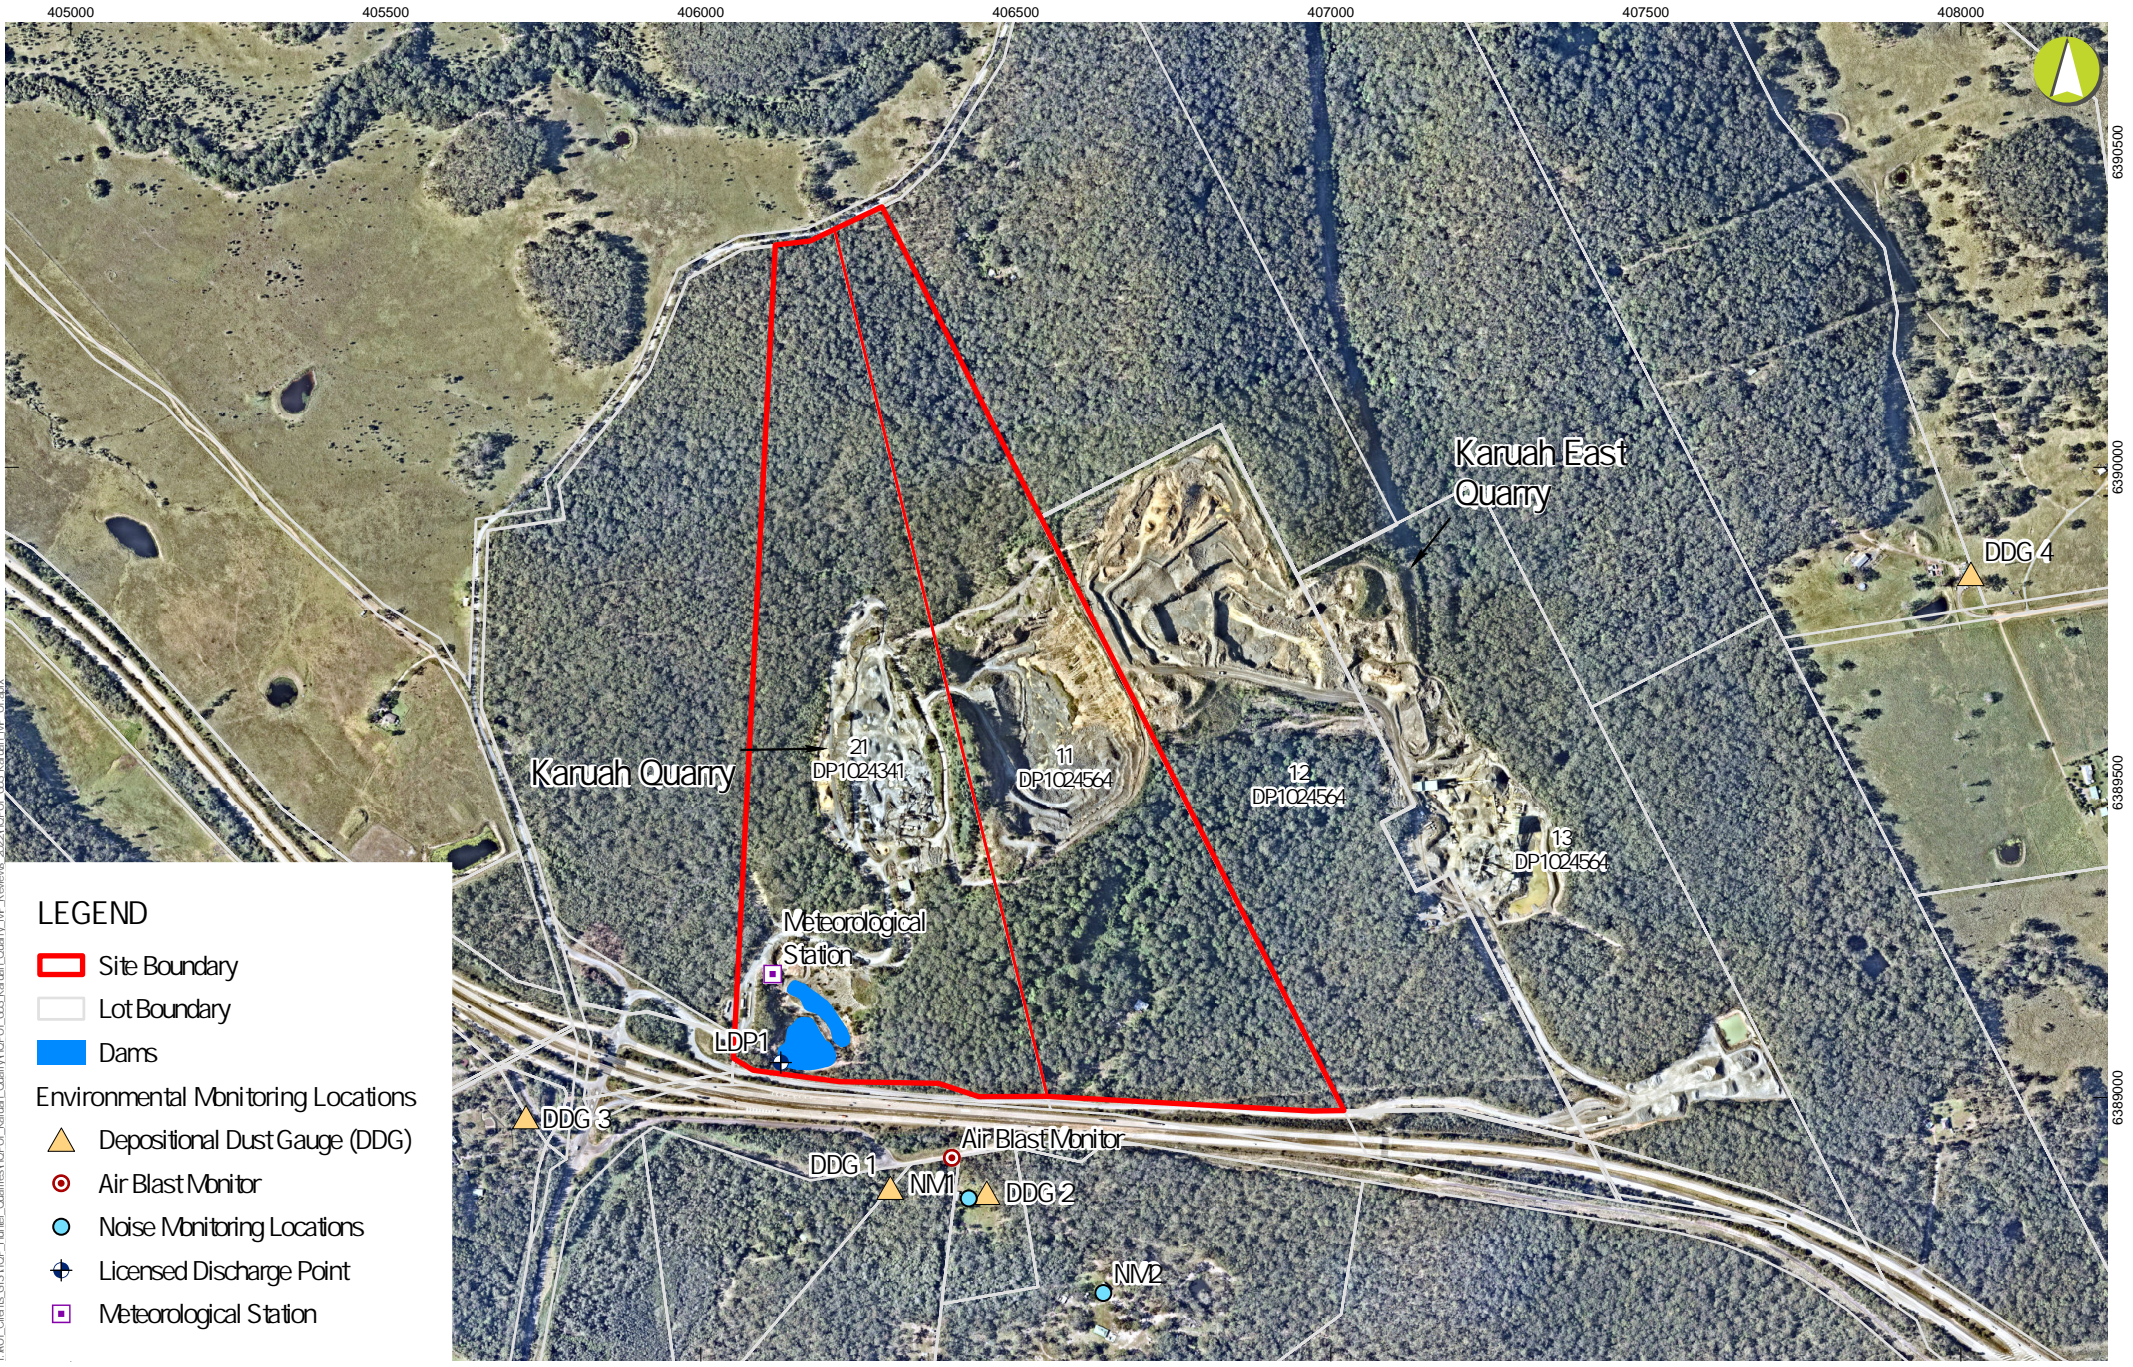
APPENDIX 1 - Environmental Monitoring Locations

Monitoring locations are illustrated by the site plan provided by **Appendix 1**.
