Tea Gardens Quarry

# Environmental Monitoring Report

July 2025

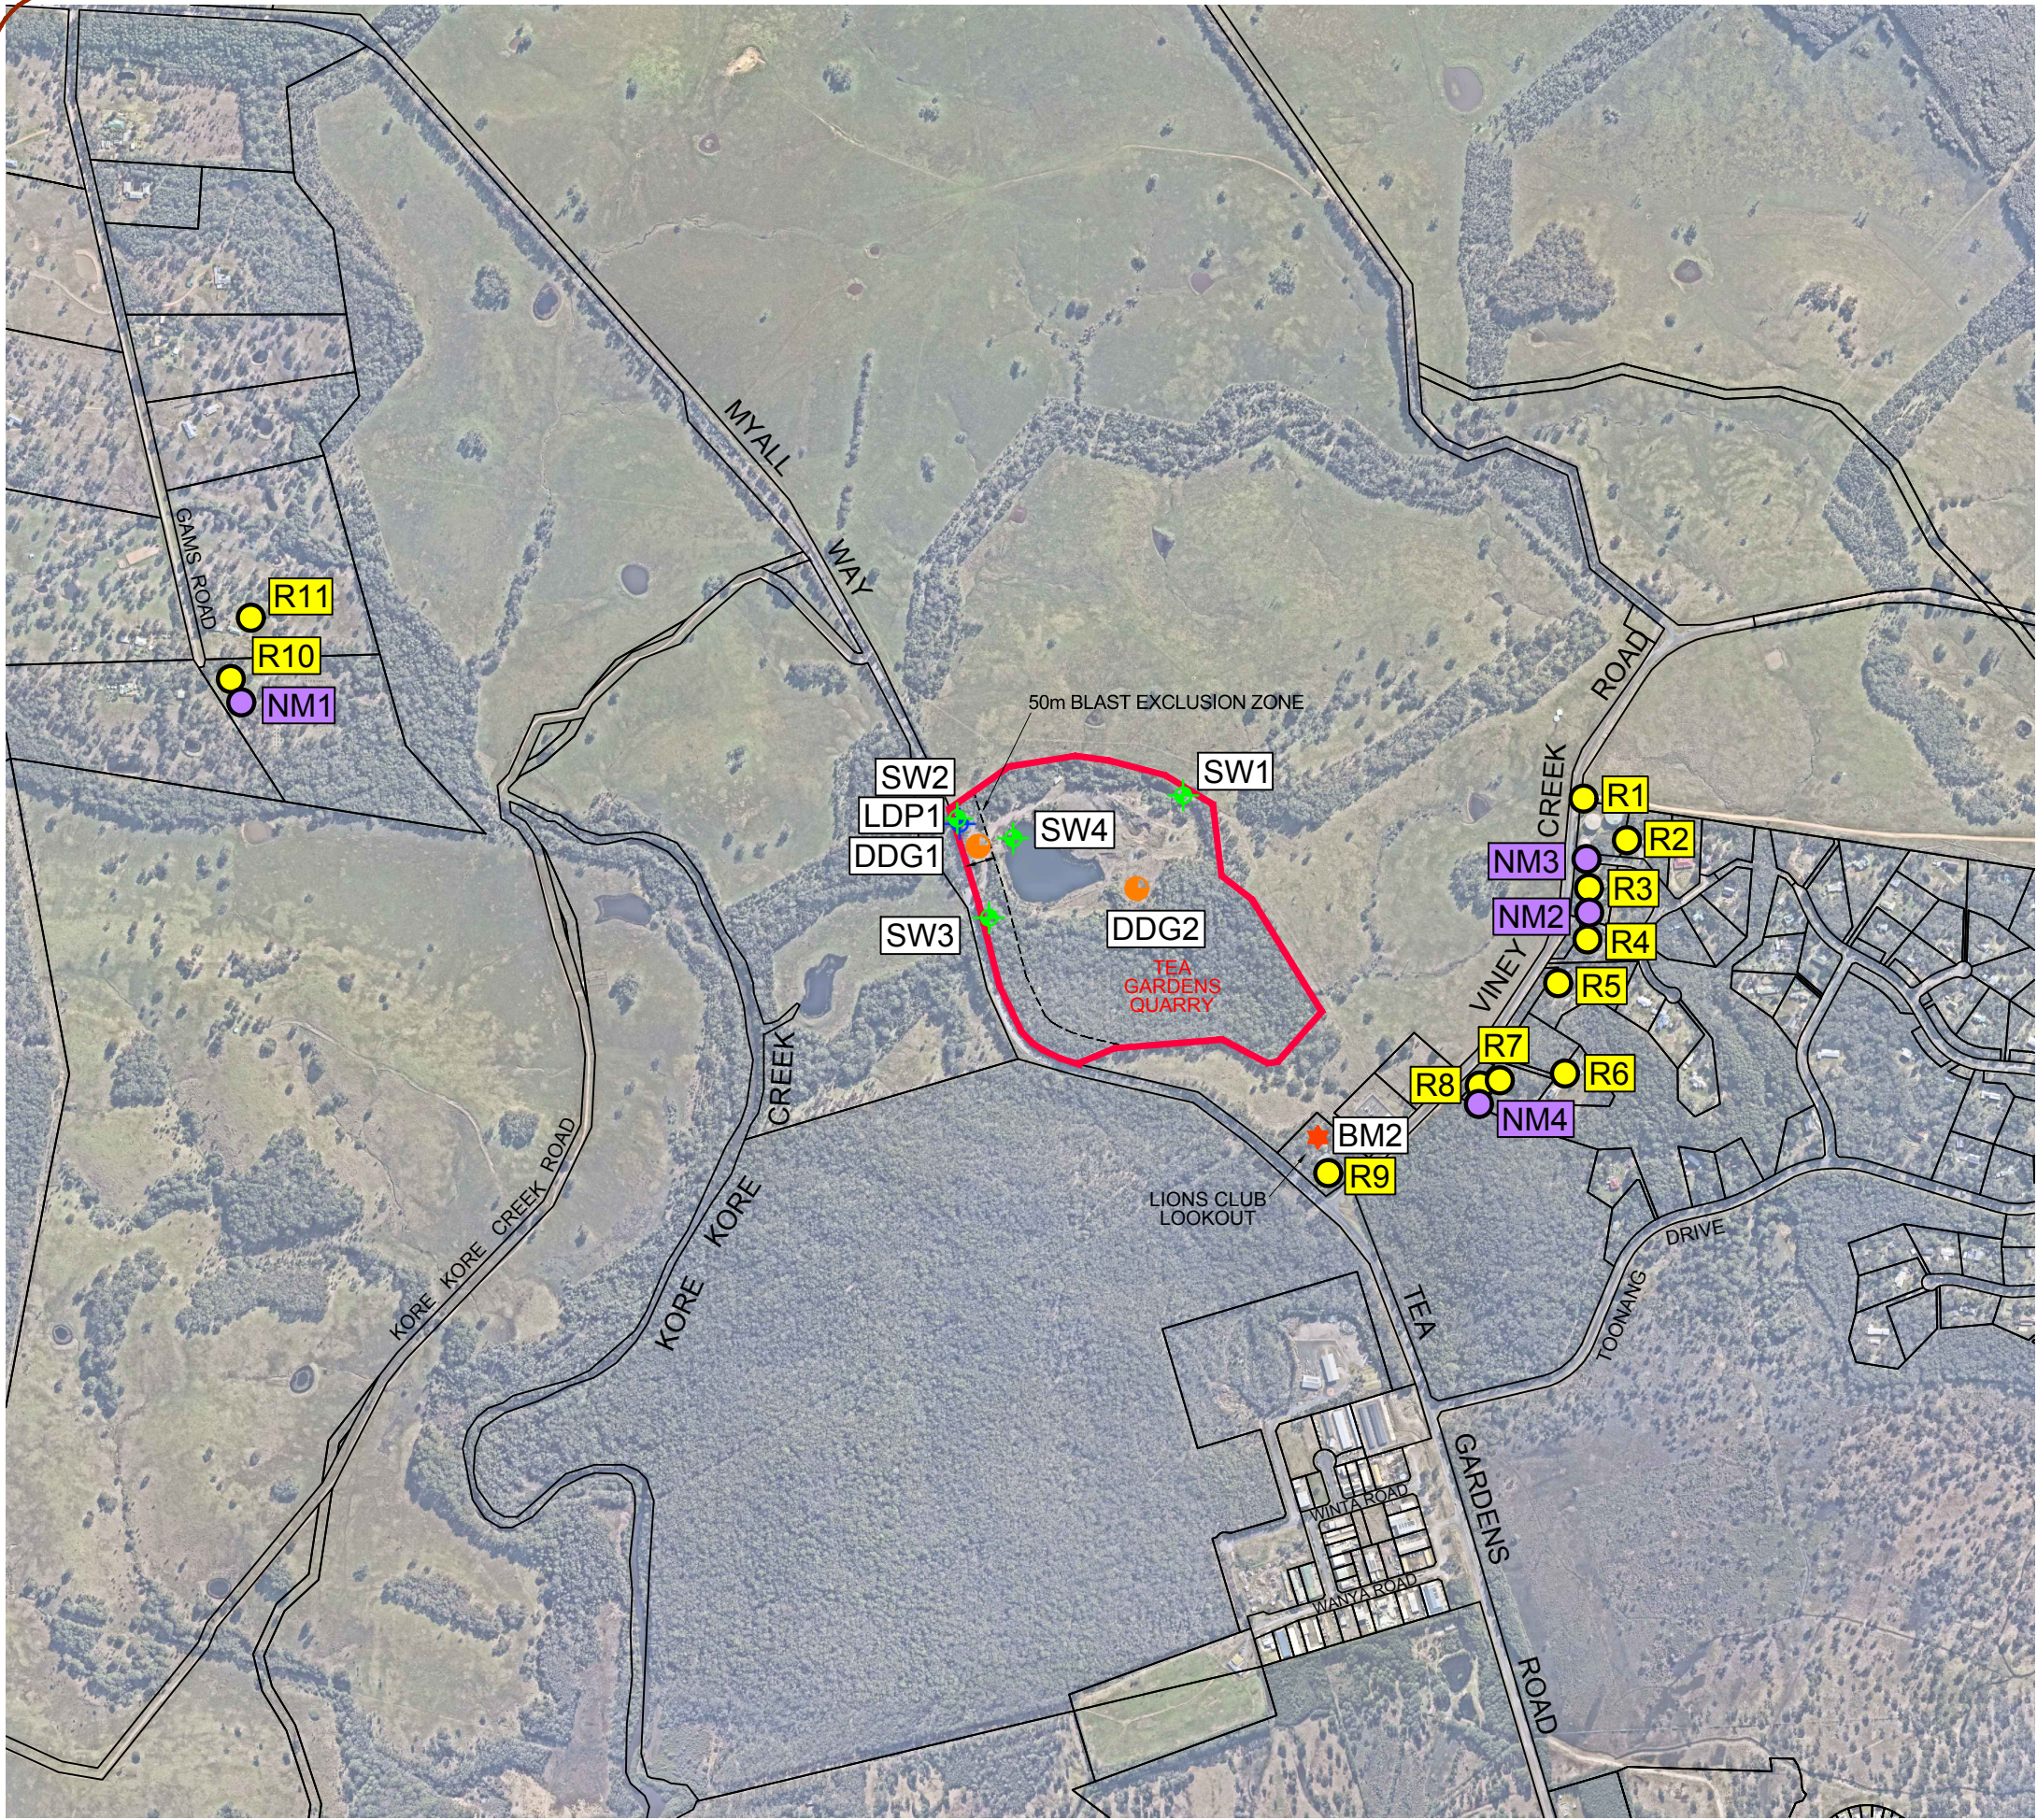
## Appendix 1 – EPL 12133 Monitoring Locations

Monitoring locations are illustrated by the site plan provided by **Appendix 1**.

ENVIRONMENTAL MONITORING  
LOCATION PLAN
