Karuah Hard Rock Quarry

Environmental Monitoring Report

August 2025

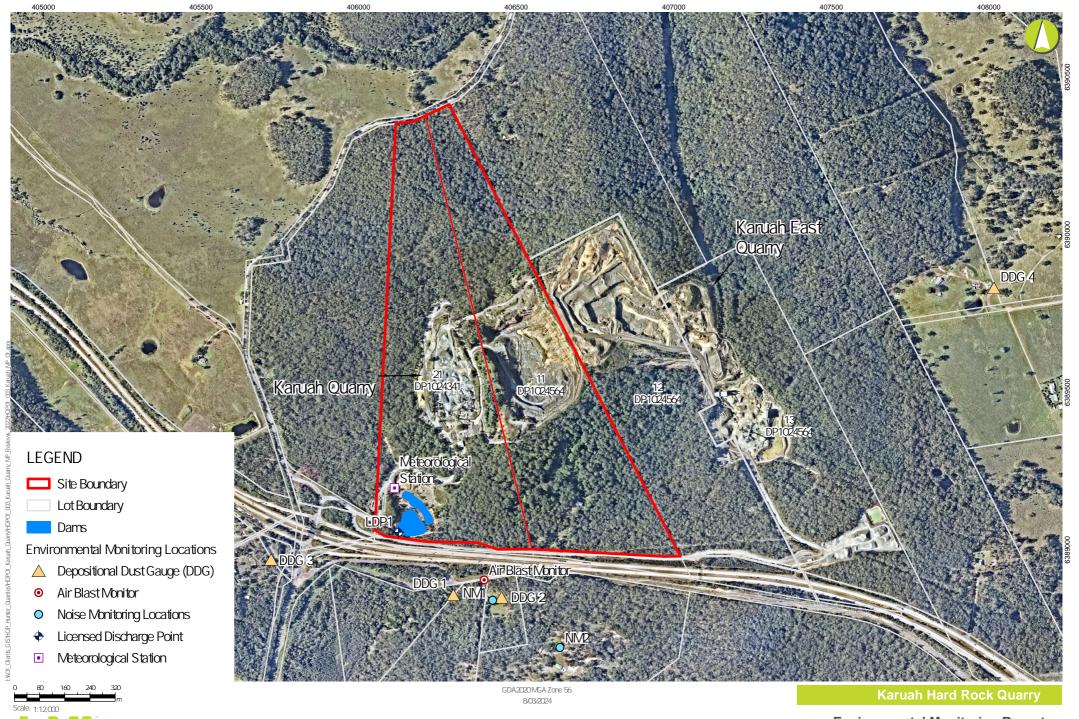
Appendix 1 – EPL 11569 Monitoring Locations

Monitoring locations are illustrated by the site plan provided by **Appendix 1**.

Environmental Monitoring Report
APPENDIX 1 - Environmental Monitoring Locations
