## Karuah Hard Rock Quarry

### Environmental Monitoring Report

November 2025

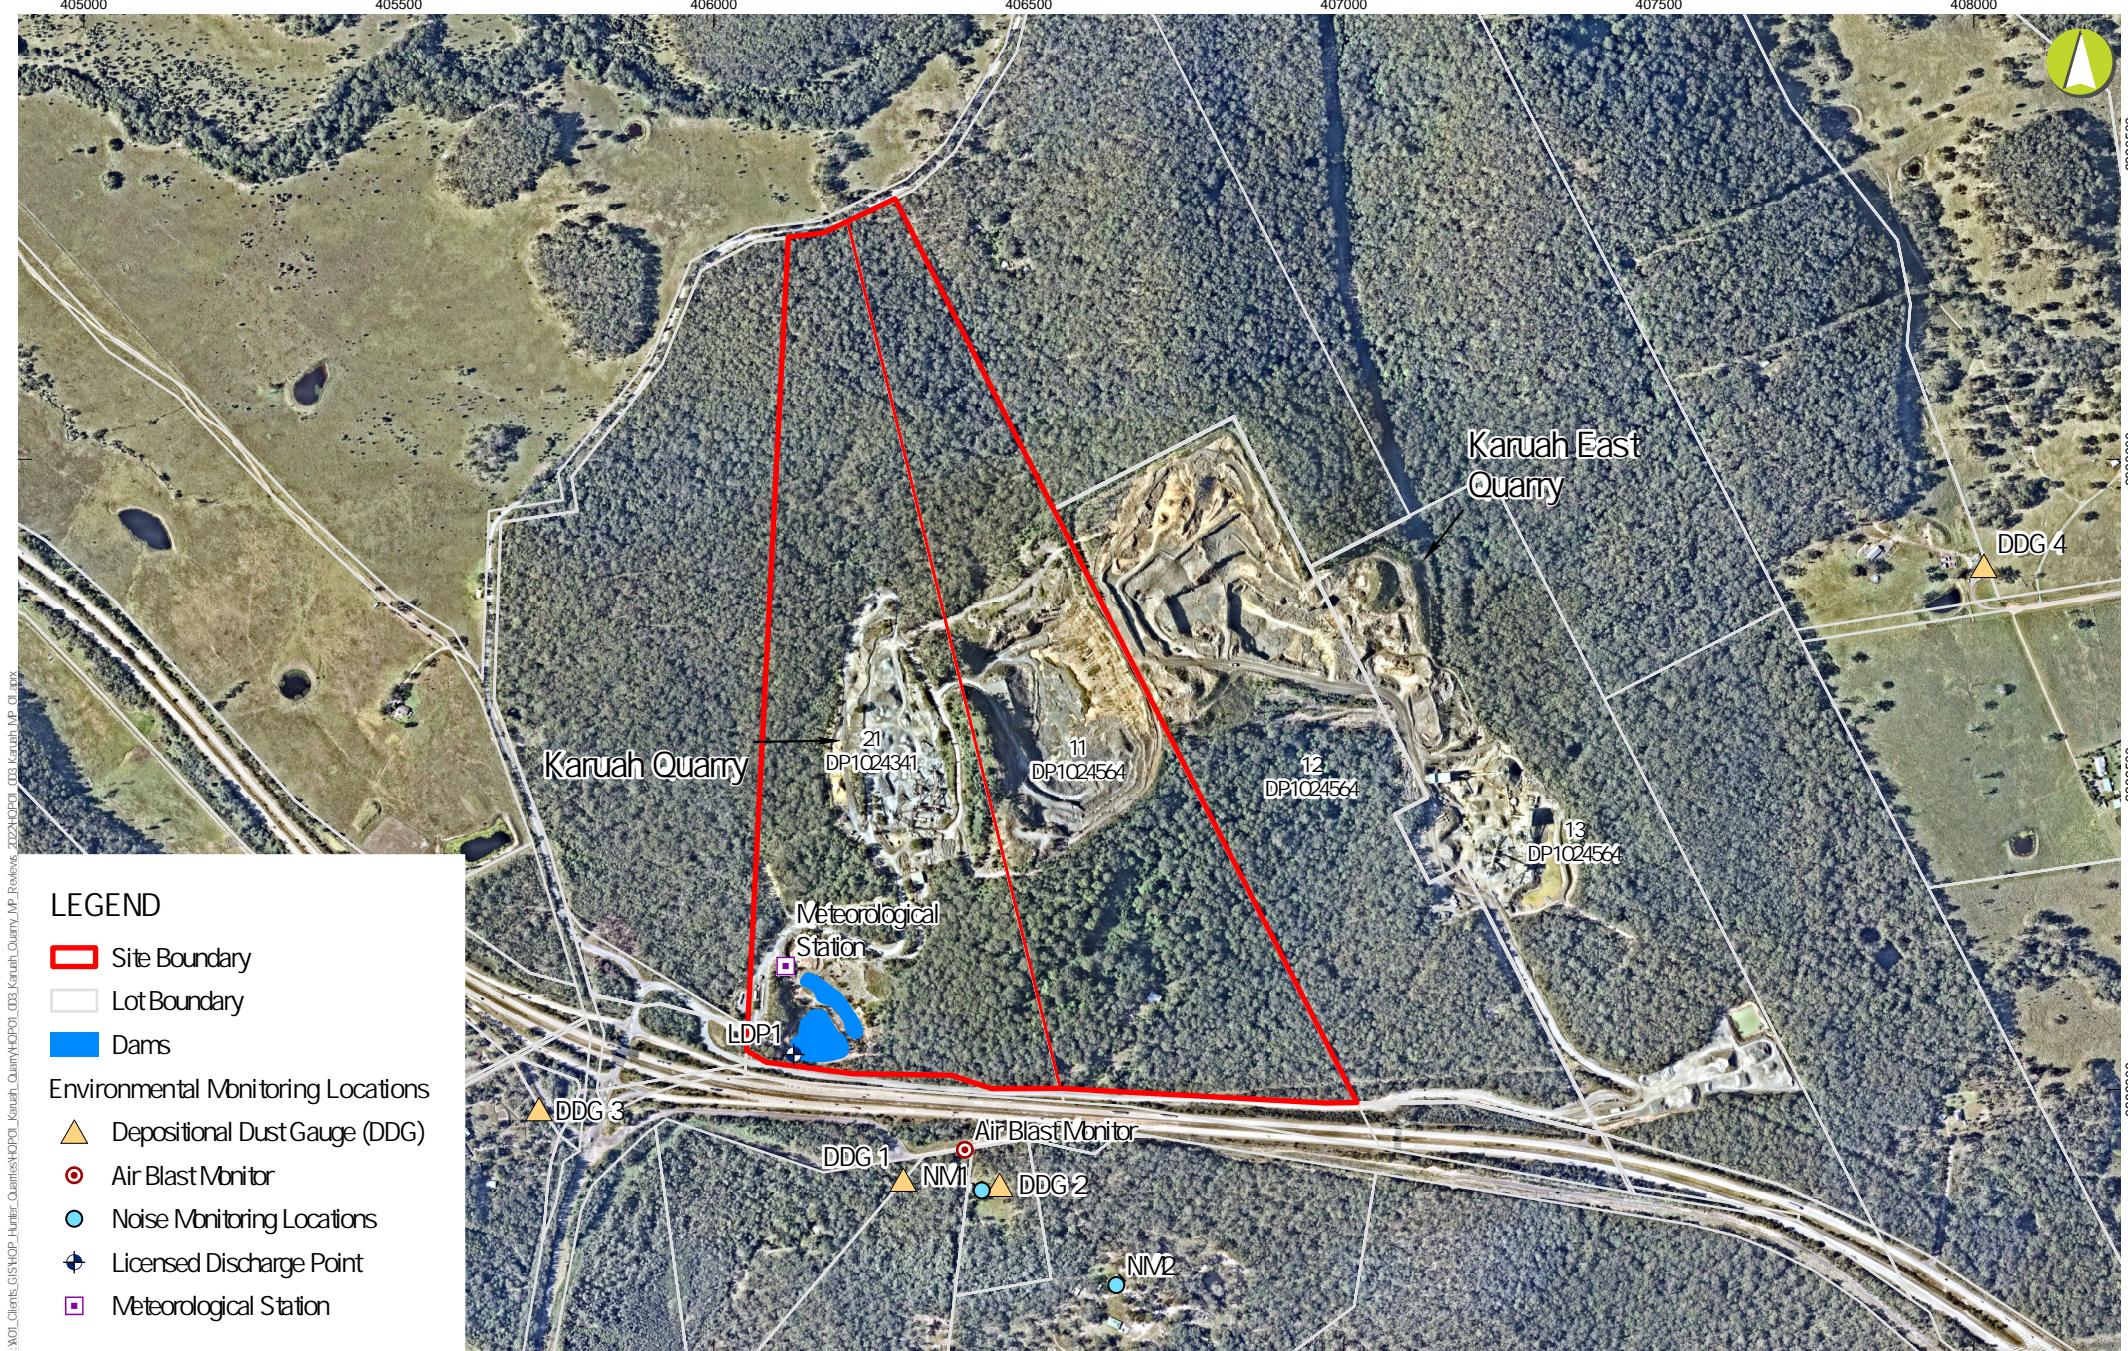
## Appendix 1 – EPL 11569 Monitoring Locations

Monitoring locations are illustrated by the site plan provided by **Appendix 1**.

### APPENDIX 1 - Environmental Monitoring Locations
