Tea Gardens Quarry

Environmental Monitoring Report

November 2025

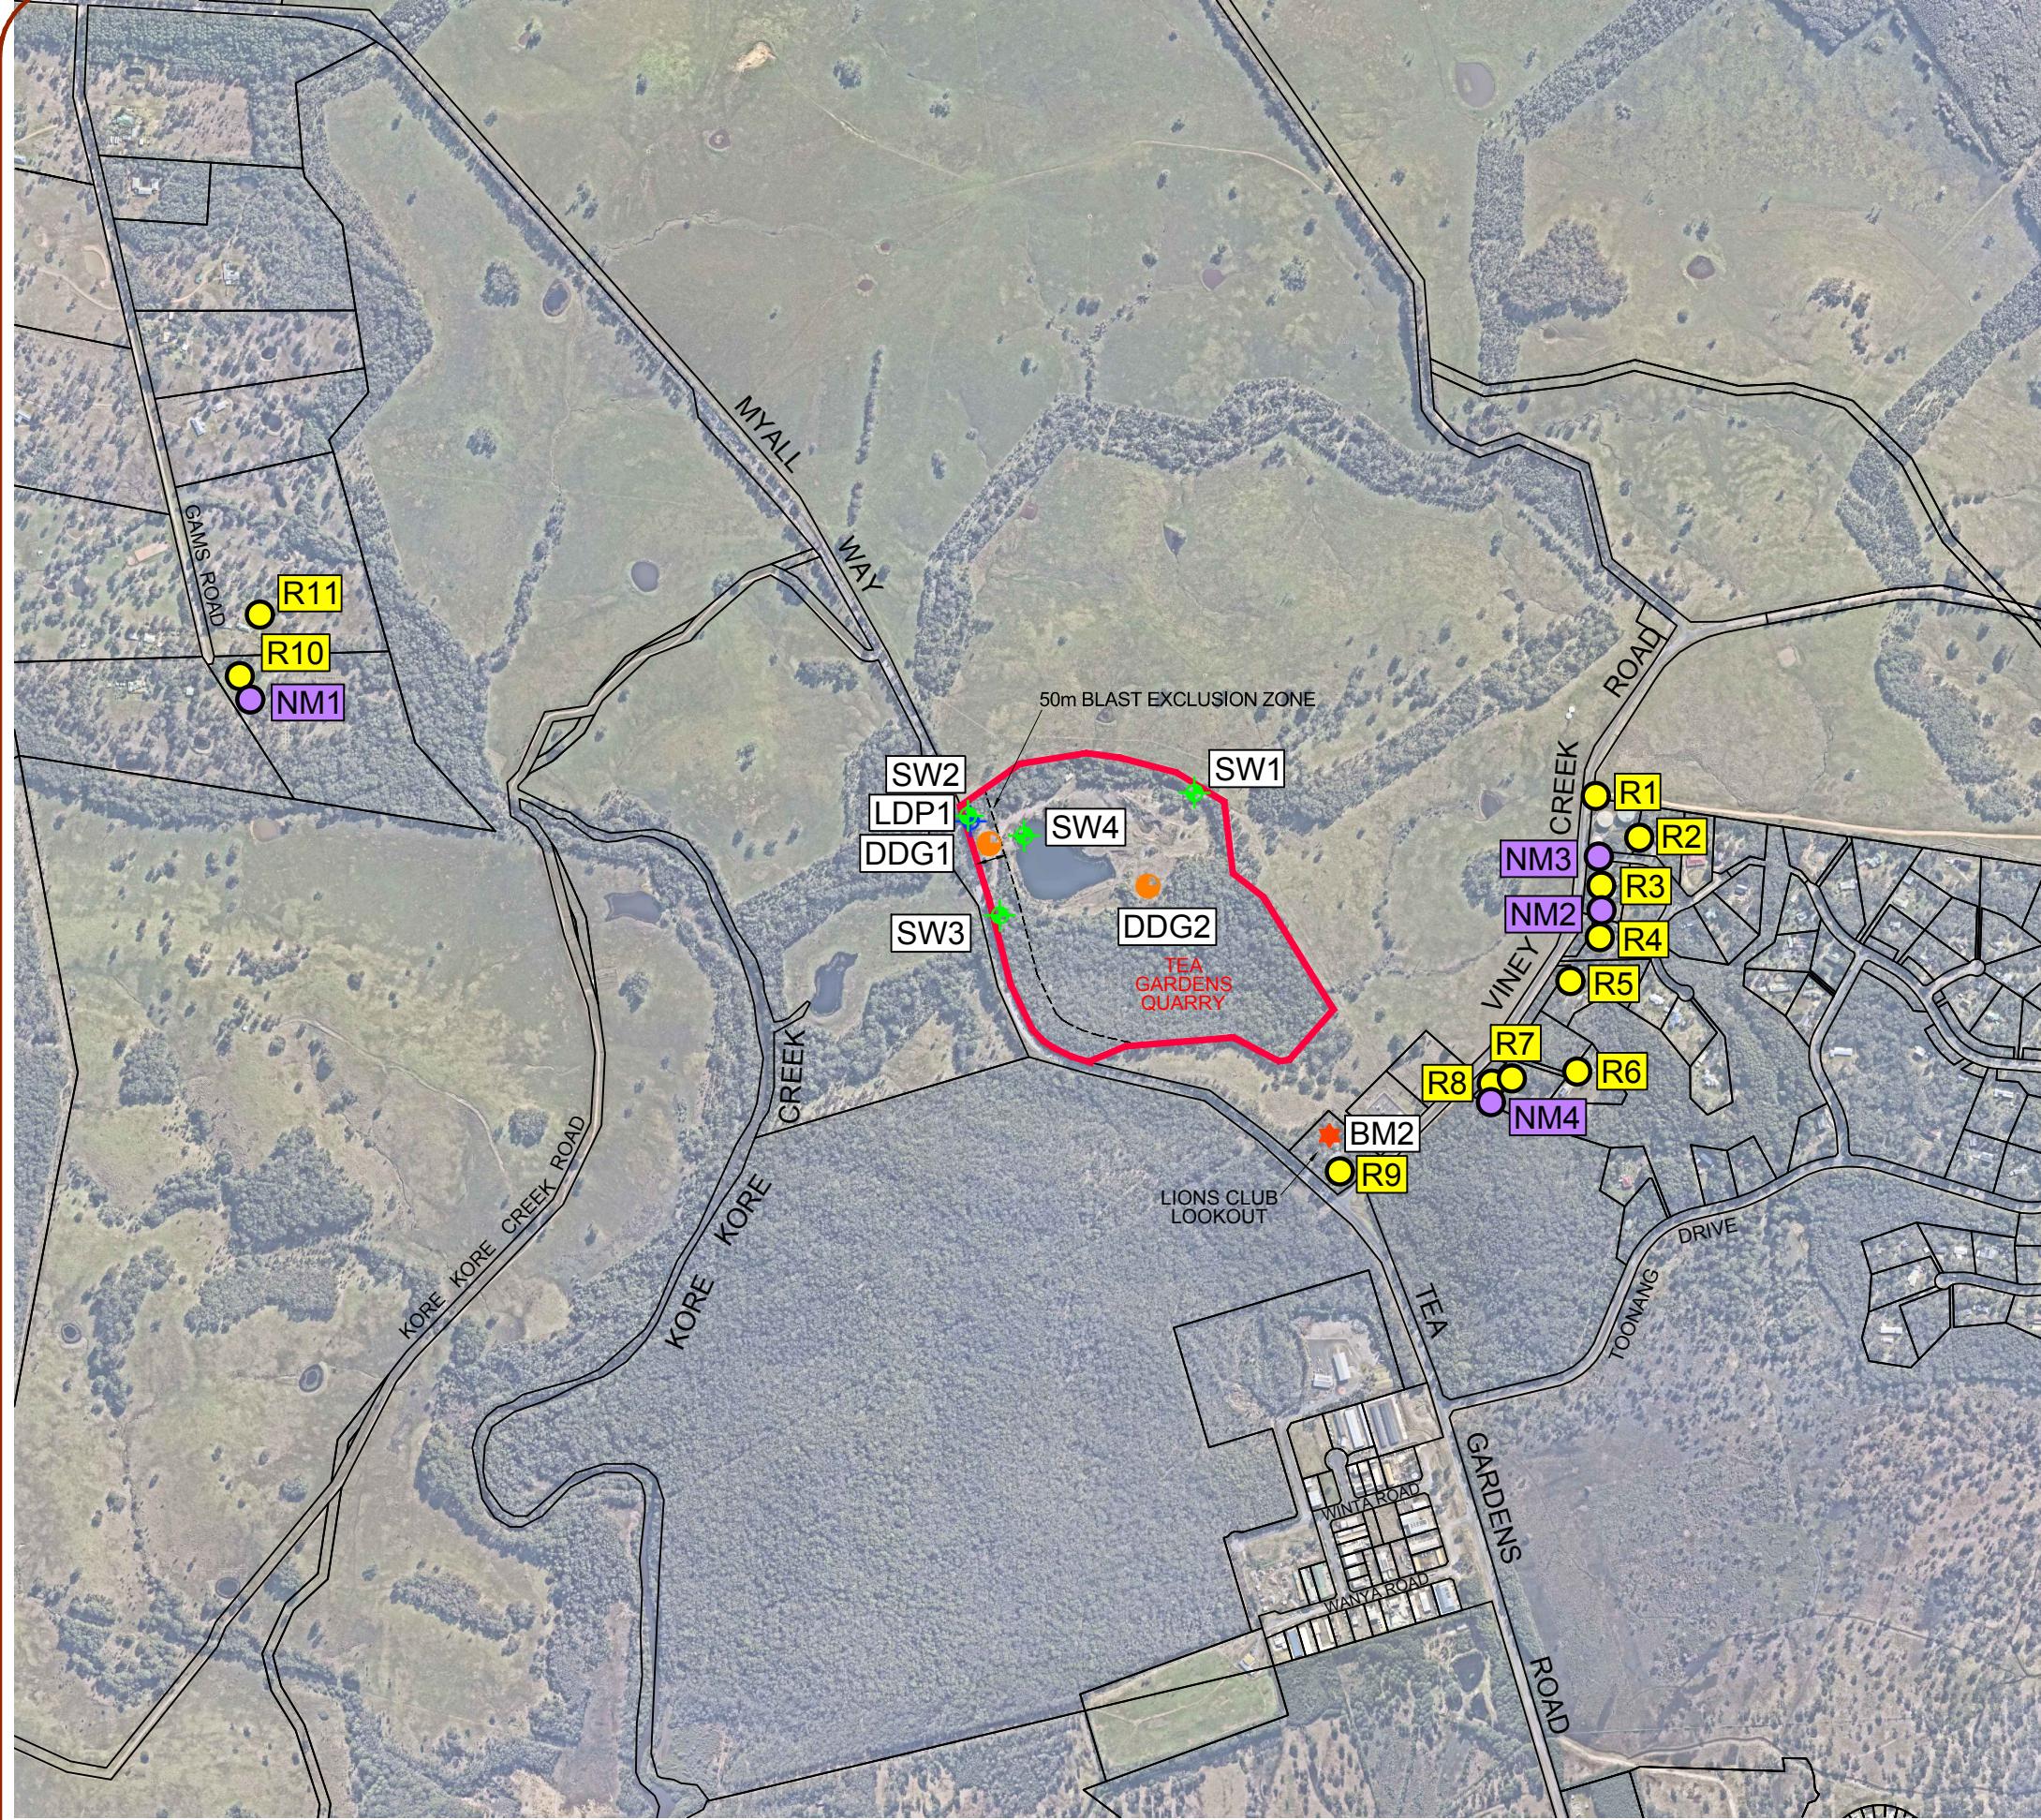
Appendix 1 – EPL 12133 Monitoring Locations

Monitoring locations are illustrated by the site plan provided by **Appendix 1**.

ENVIRONMENTAL MONITORING LOCATION PLAN

Site Monitoring Point ID	Site Coordinates (MGA56, GDA 2020)	Site Location
DDG 1	E 419,125; N 6,388,905	West of the operational quarry area.
DDG 2	E 419,405; N 6,388,830	South-east of the operational quarry area.
