Tea Gardens Quarry

Environmental Monitoring Report

December 2025

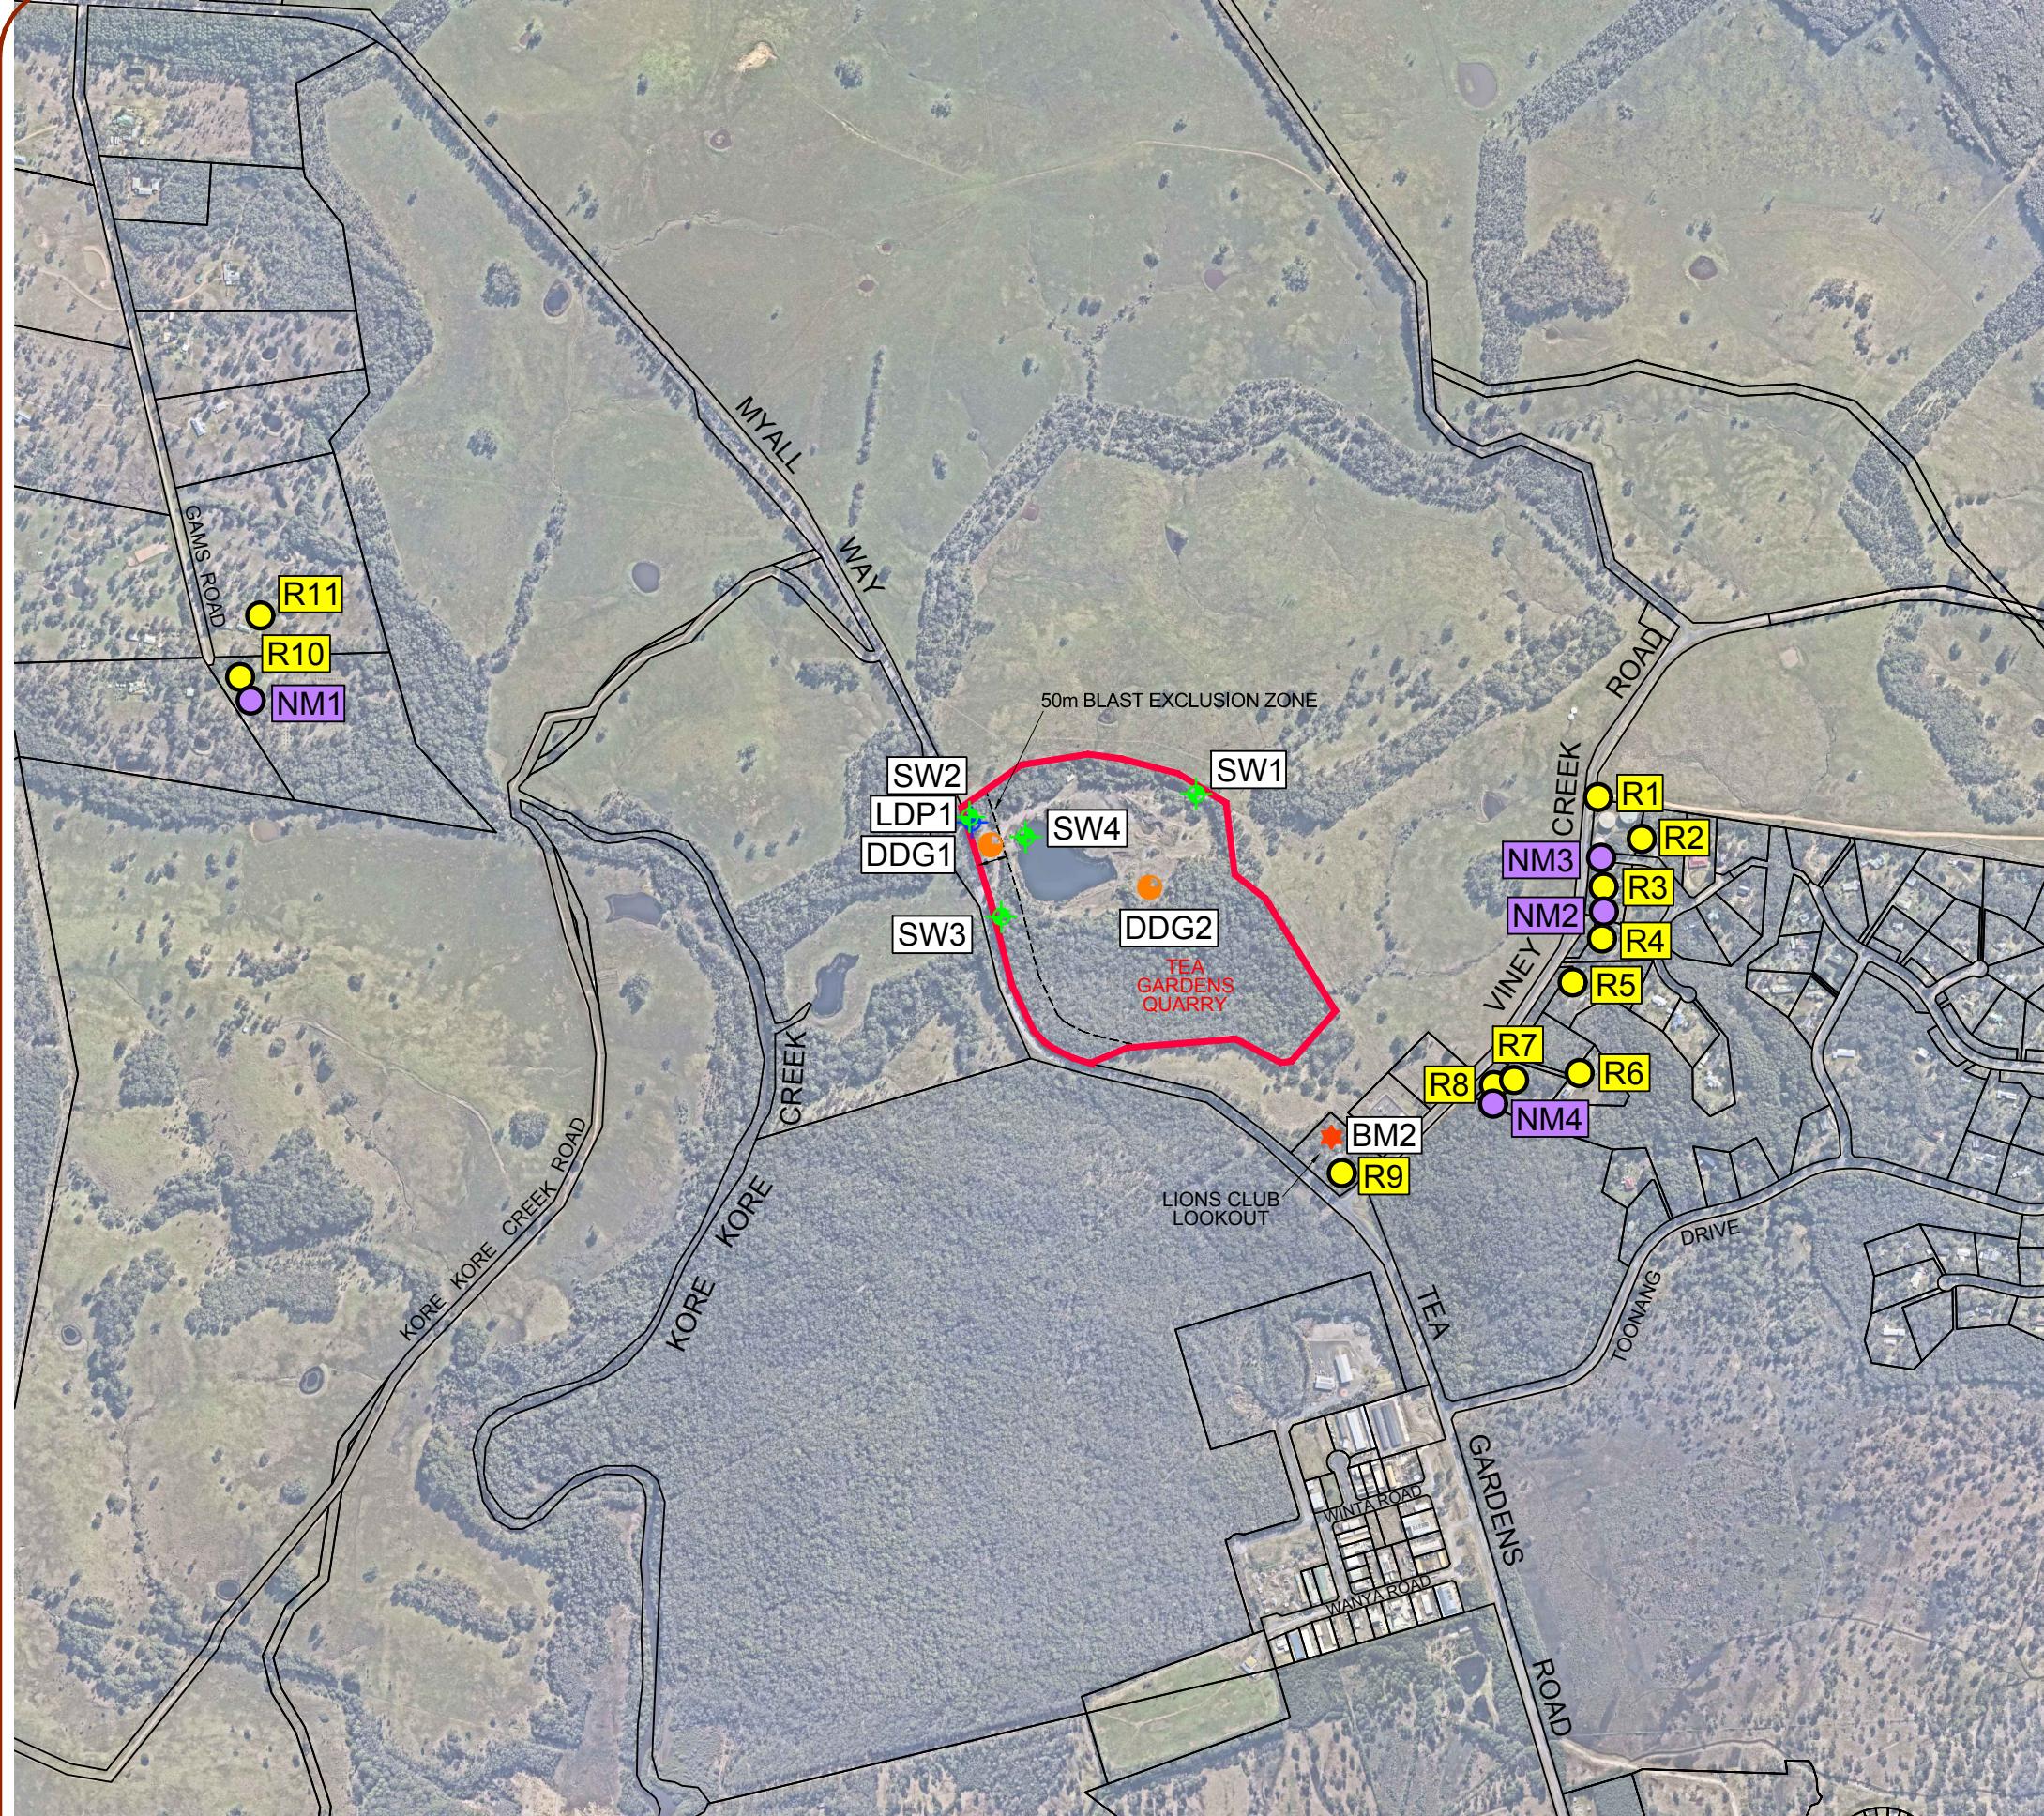
Appendix 1 – EPL 12133 Monitoring Locations

Monitoring locations are illustrated by the site plan provided by **Appendix 1**.

ENVIRONMENTAL MONITORING LOCATION PLAN
