Karuah Hard Rock Quarry

Environmental Monitoring Report

February 2026

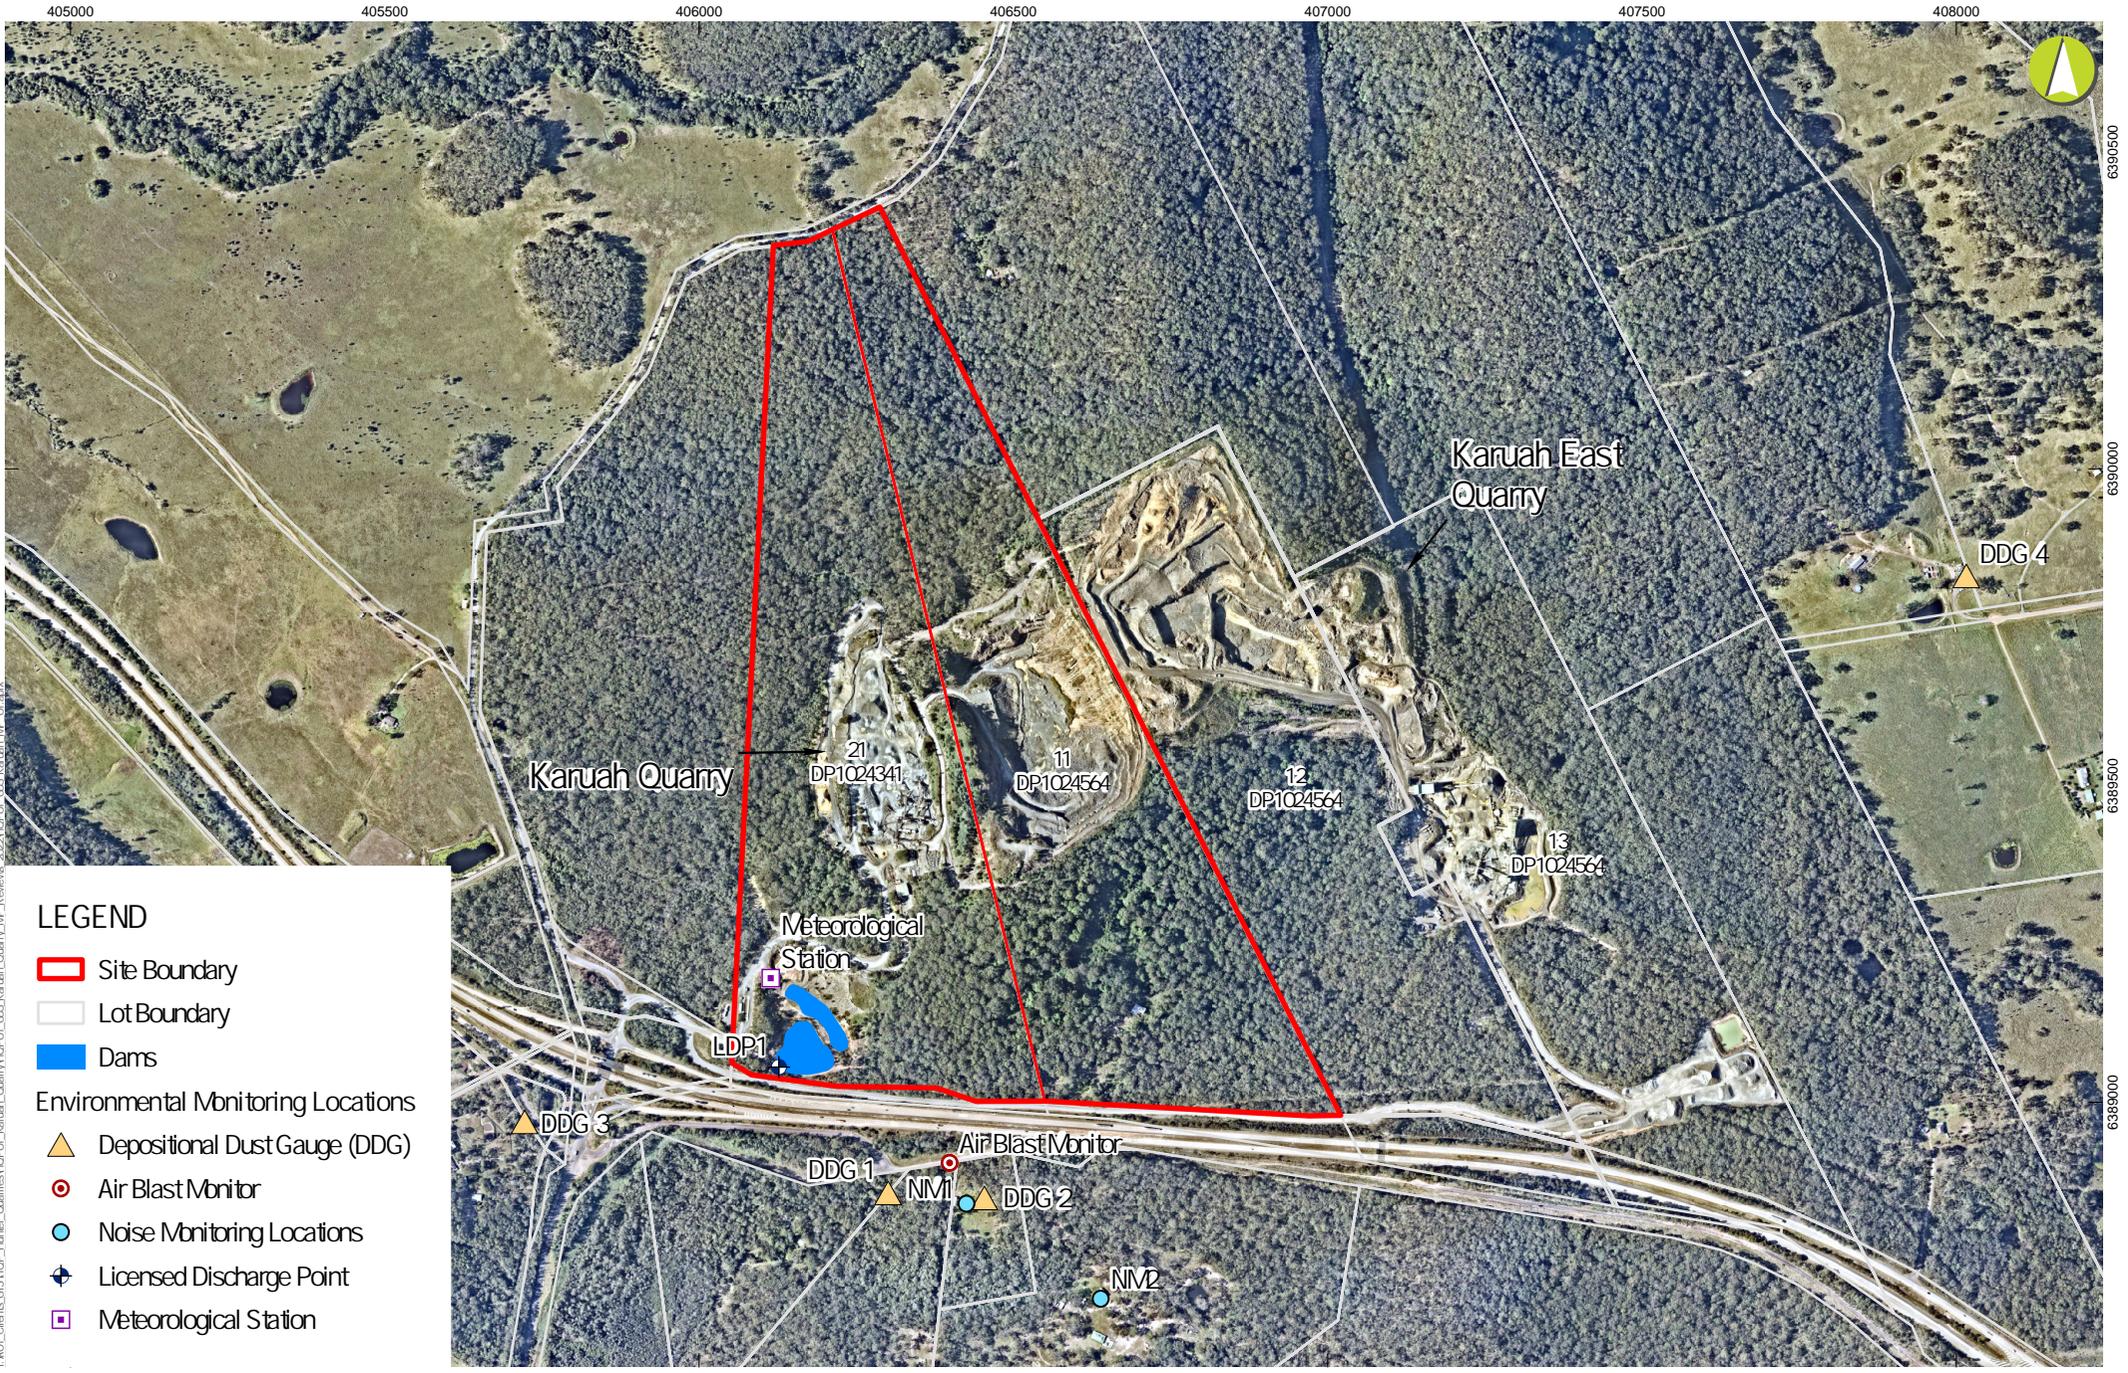
Appendix 1 – EPL 11569 Monitoring Locations

Monitoring locations are illustrated by the site plan provided by **Appendix 1**.

- Site Boundary
- Lot Boundary
- Dams
- Environmental Monitoring Locations**
- ▲ Depositional Dust Gauge (DDG)
- ⊙ Air Blast Monitor
- Noise Monitoring Locations
- ⊕ Licensed Discharge Point
- ⊞ Meteorological Station
