Tea Gardens Quarry

Environmental Monitoring Report

March 2026

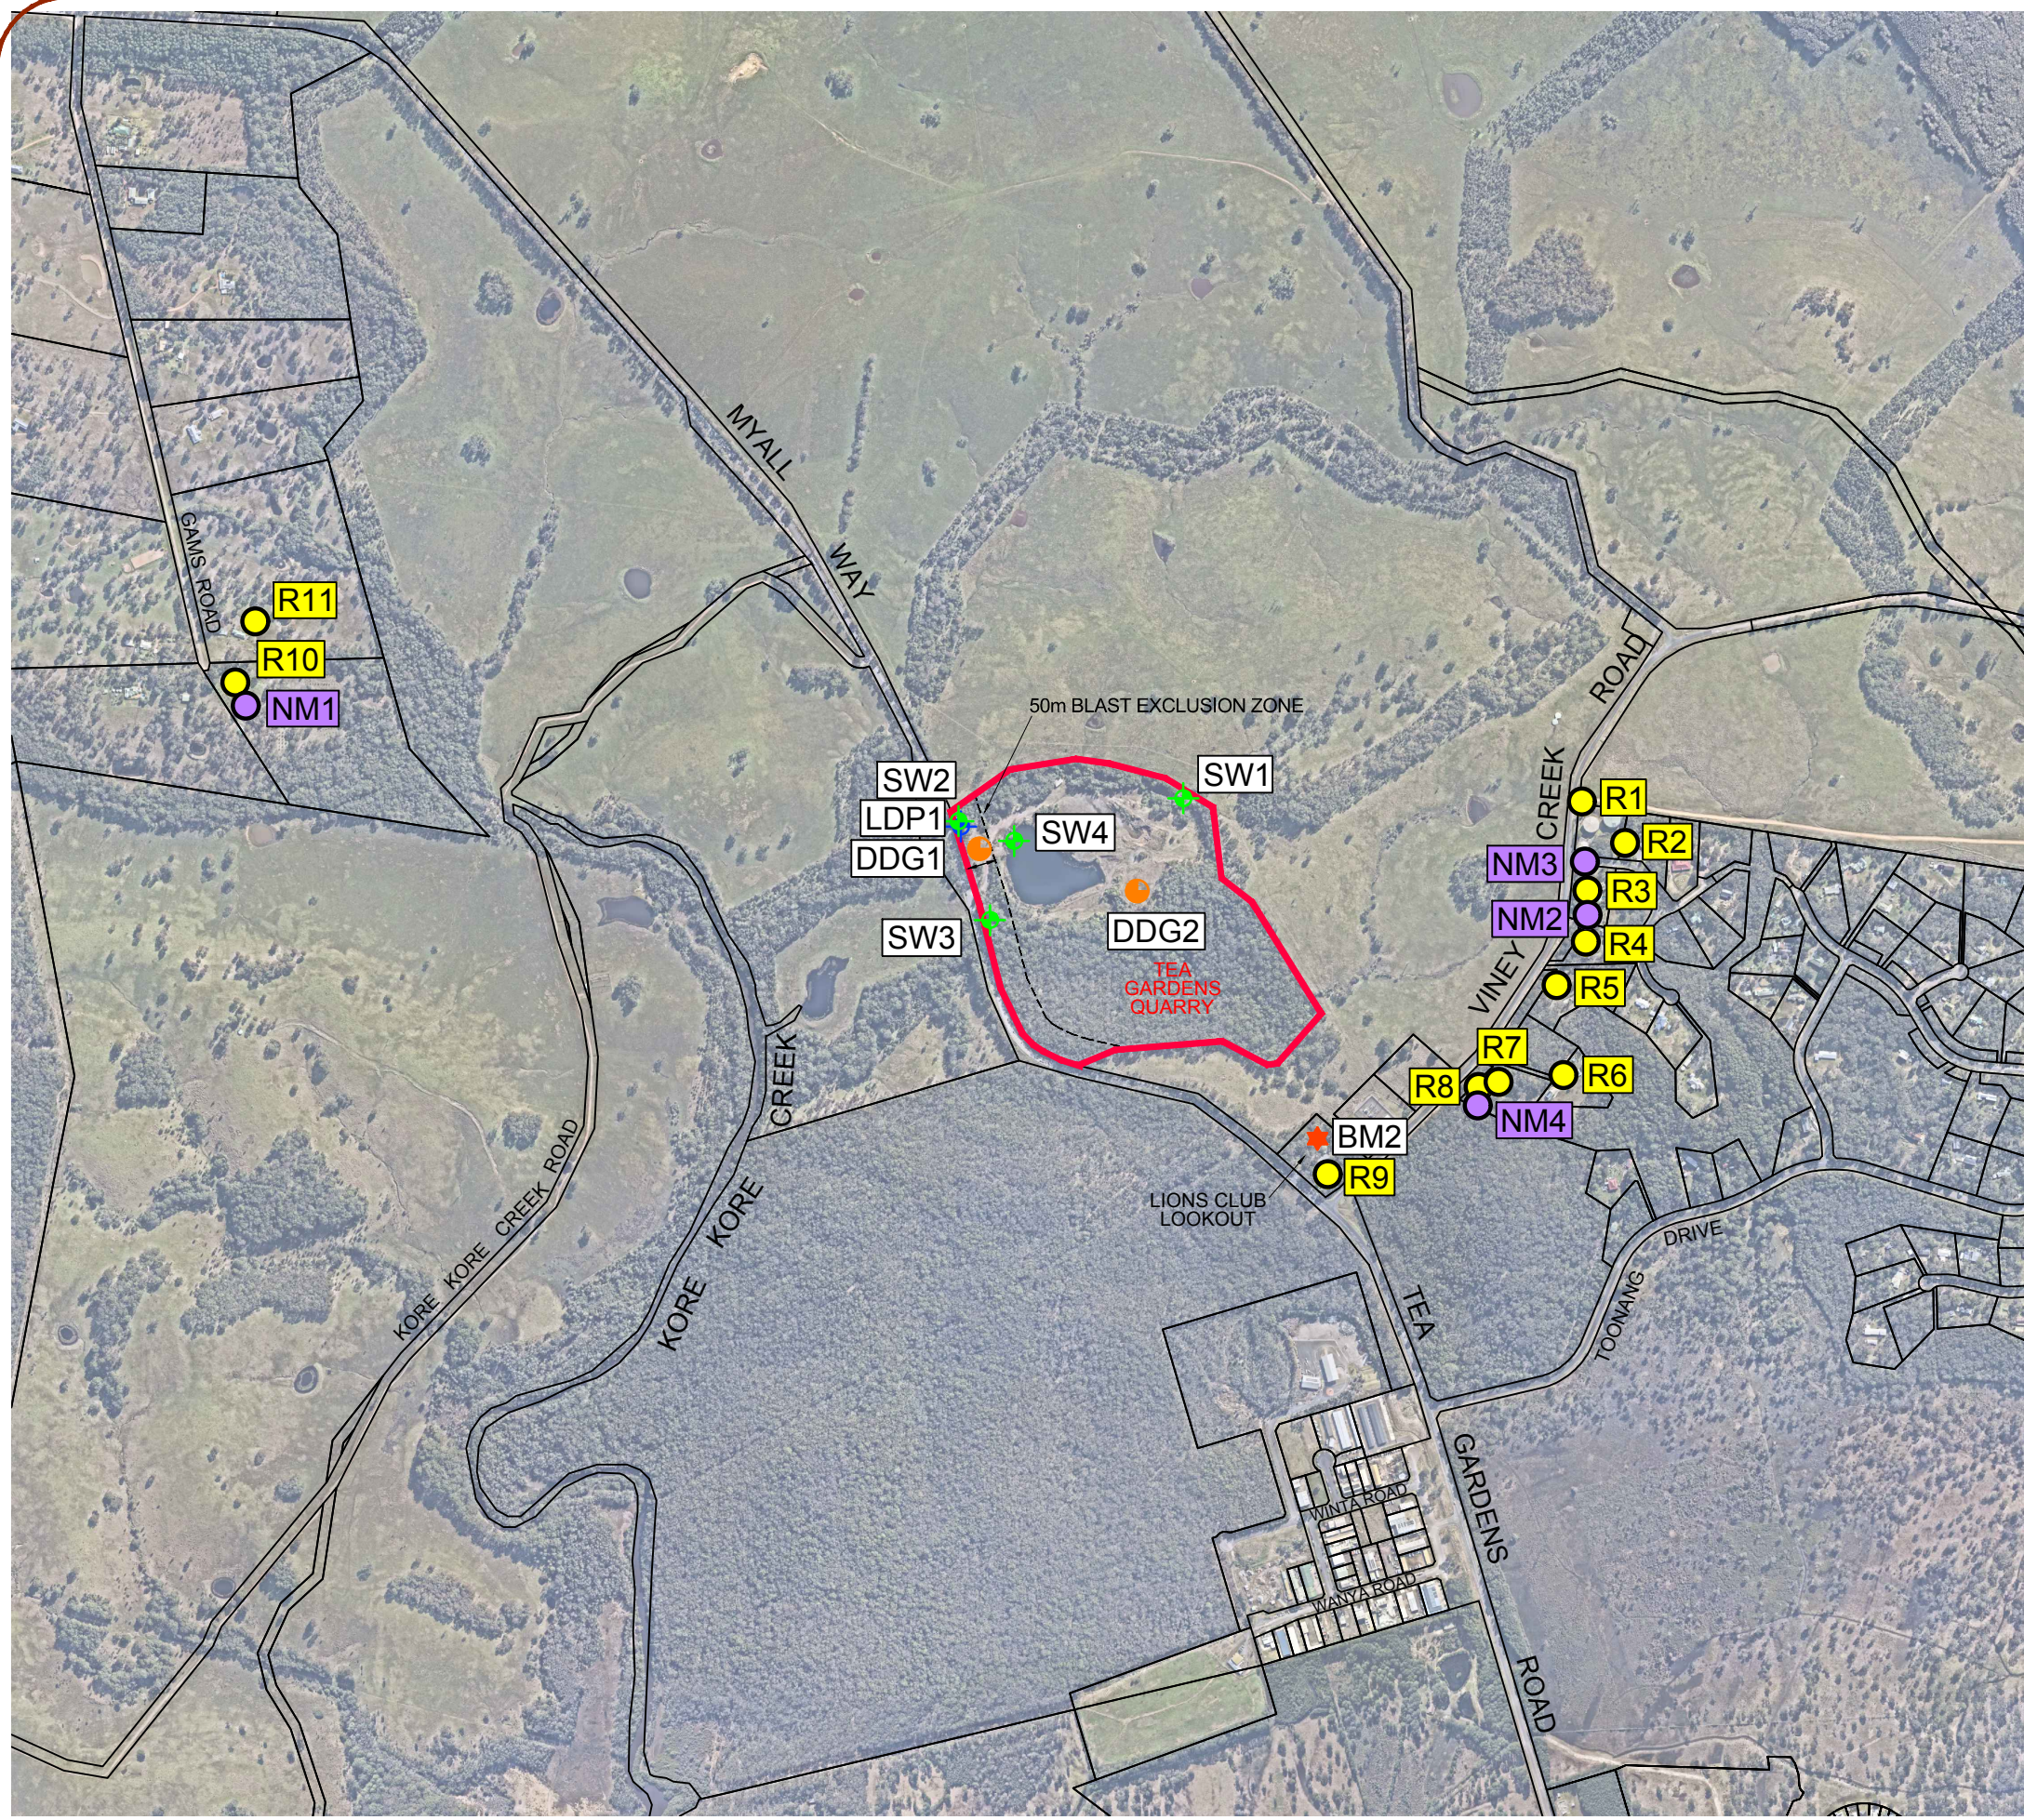
drawing title:
APPENDIX 1:
ENVIRONMENTAL MONITORING
LOCATION PLAN

Monitoring locations are illustrated by the site plan provided by **Appendix 1**.

Site Monitoring Point ID	Site Coordinates (MGA56, GDA 2020)	Site Location
DDG 1	E 419,125; N 6,388,905	West of the operational quarry area.
DDG 2	E 419,405; N 6,388,830	South-east of the operational quarry area.
