Karuah Hard Rock Quarry

## Environmental Monitoring Report

April 2026

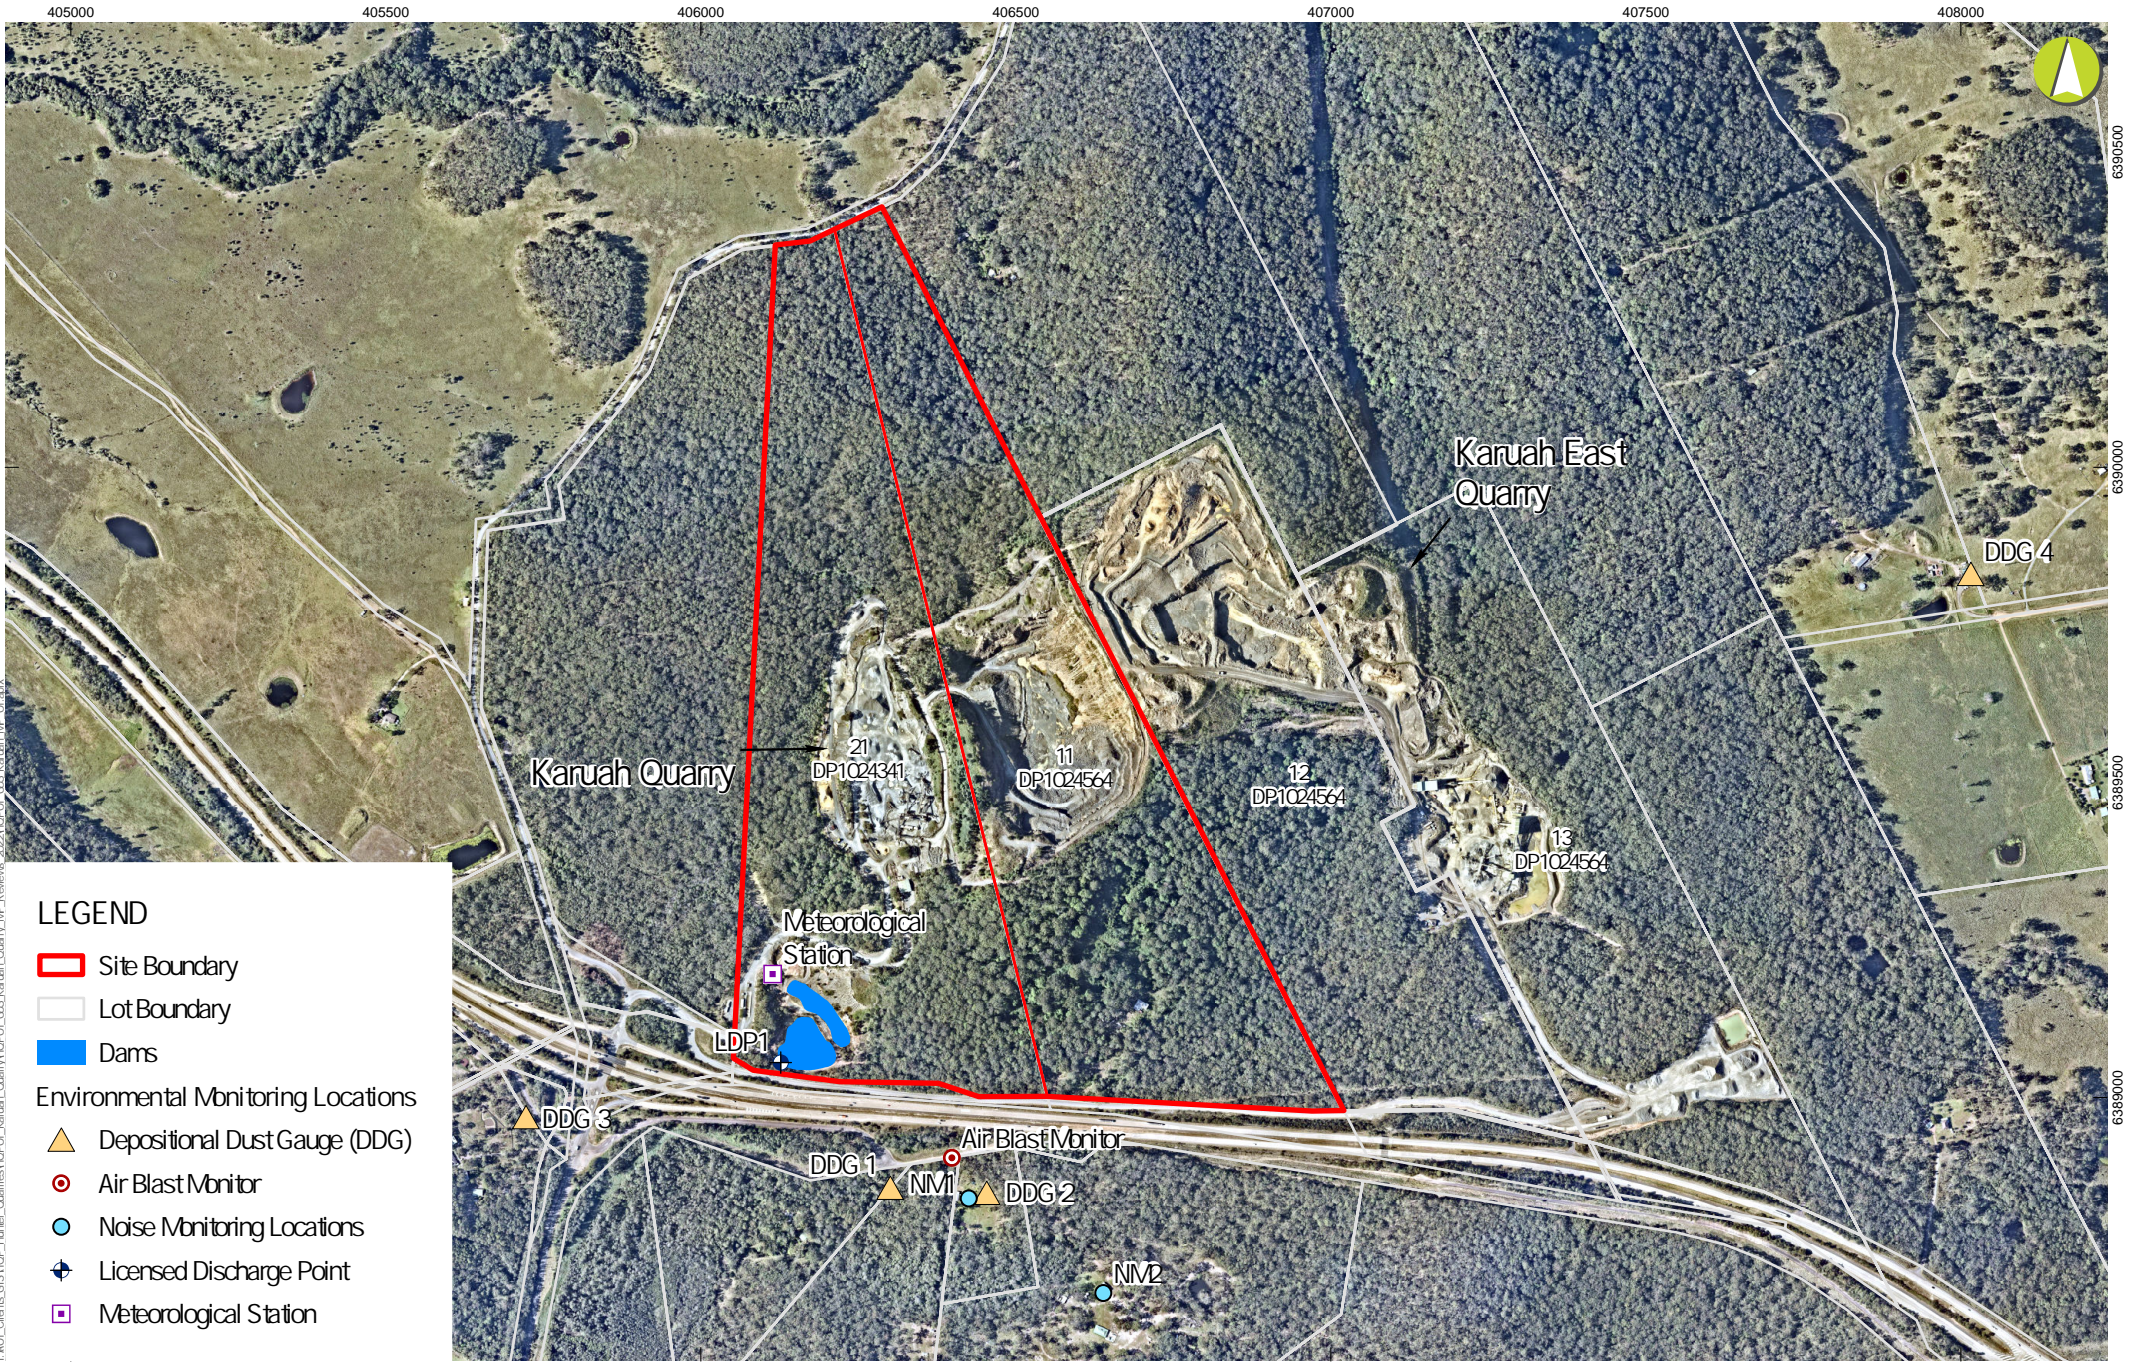
**APPENDIX 1 - Environmental Monitoring Locations**

Monitoring locations are illustrated by the site plan provided by **Appendix 1**.
