Karuah East Quarry - Community Consultative Committee

Meeting Minutes – 14 September 2020

Site Inspection Record – 14 September 2020

Company Report & Overview of Activities

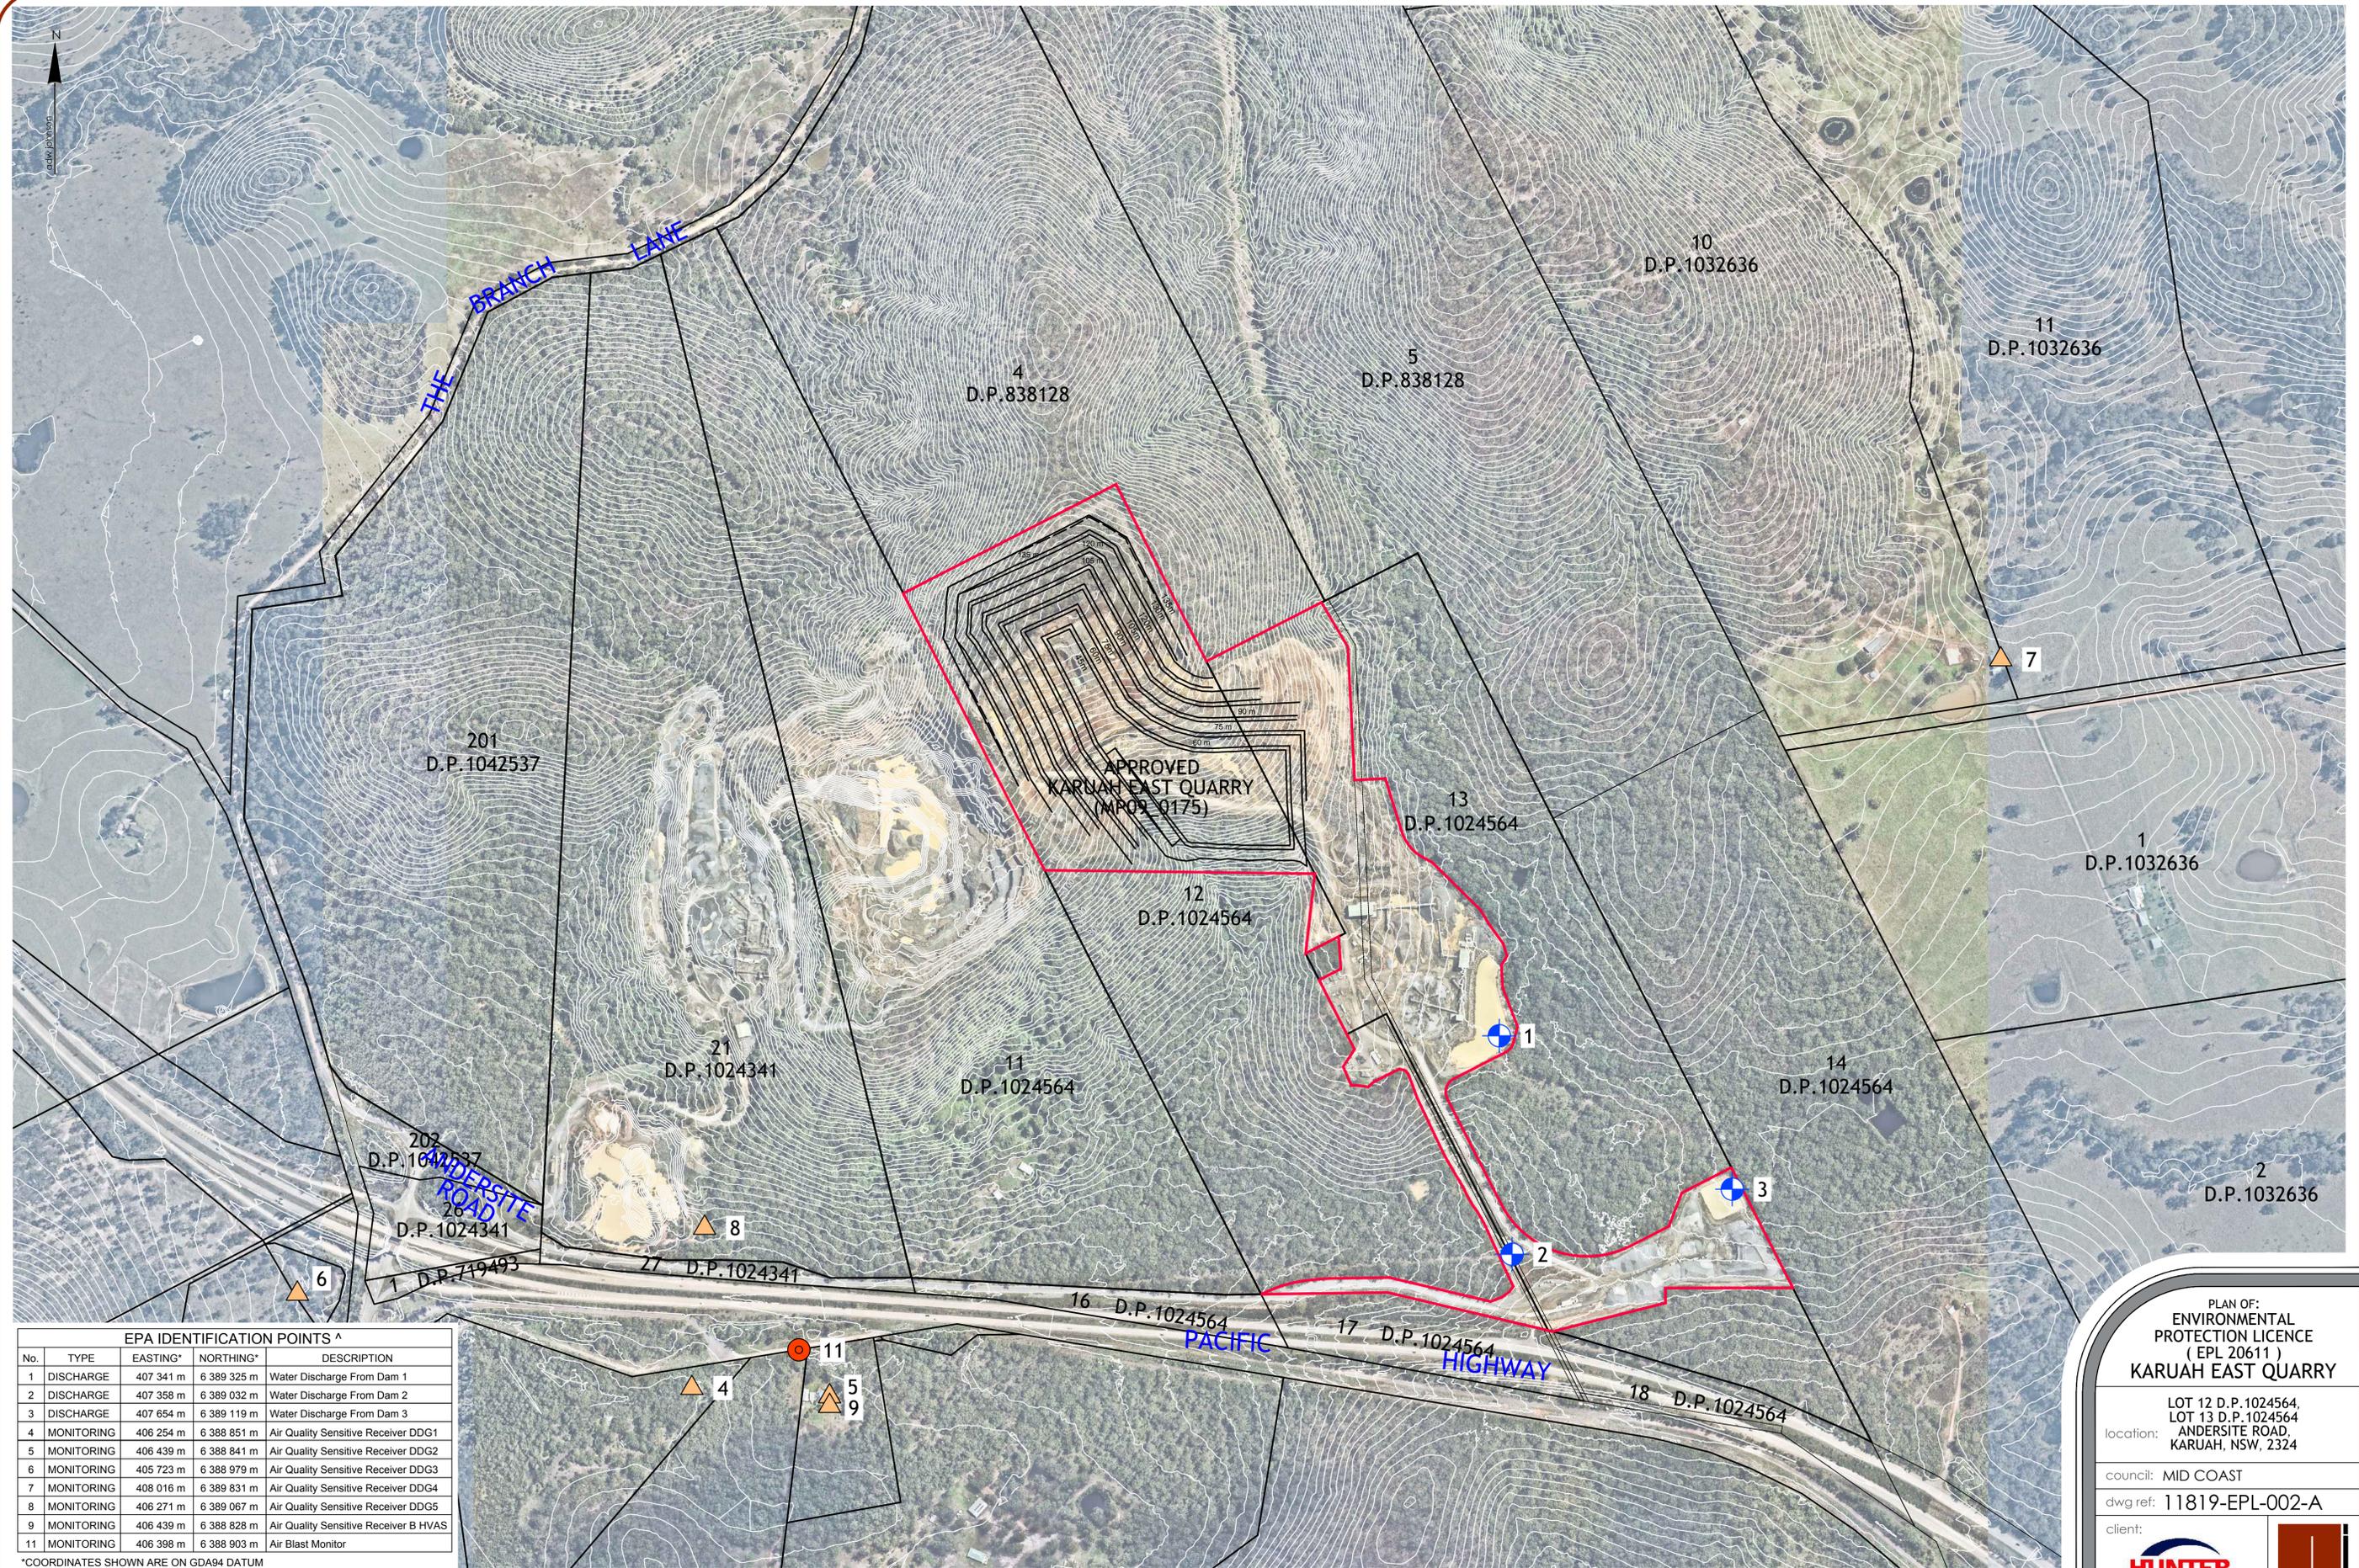
Appendix 1 – EPL 20611 Monitoring Locations

EPA IDENTIFICATION POINTS ^
