Environmental Monitoring Report February 2021

This report has been completed to meet the requirements of Section 66(6) of the *Protection of the Environment Operations Act 1997* and the NSW Environmental Protection Authority's (EPA) *Requirements for Publishing Pollution Monitoring Data* (EPA, 2013). This report summarises the required monitoring data under *Environmental Protection Licence 11569* (the EPL) (see Table 1) and *Development Consent 265-10-2004* (the Consent) (see Table 2) for the Karuah Hard Rock Quarry (the Quarry).

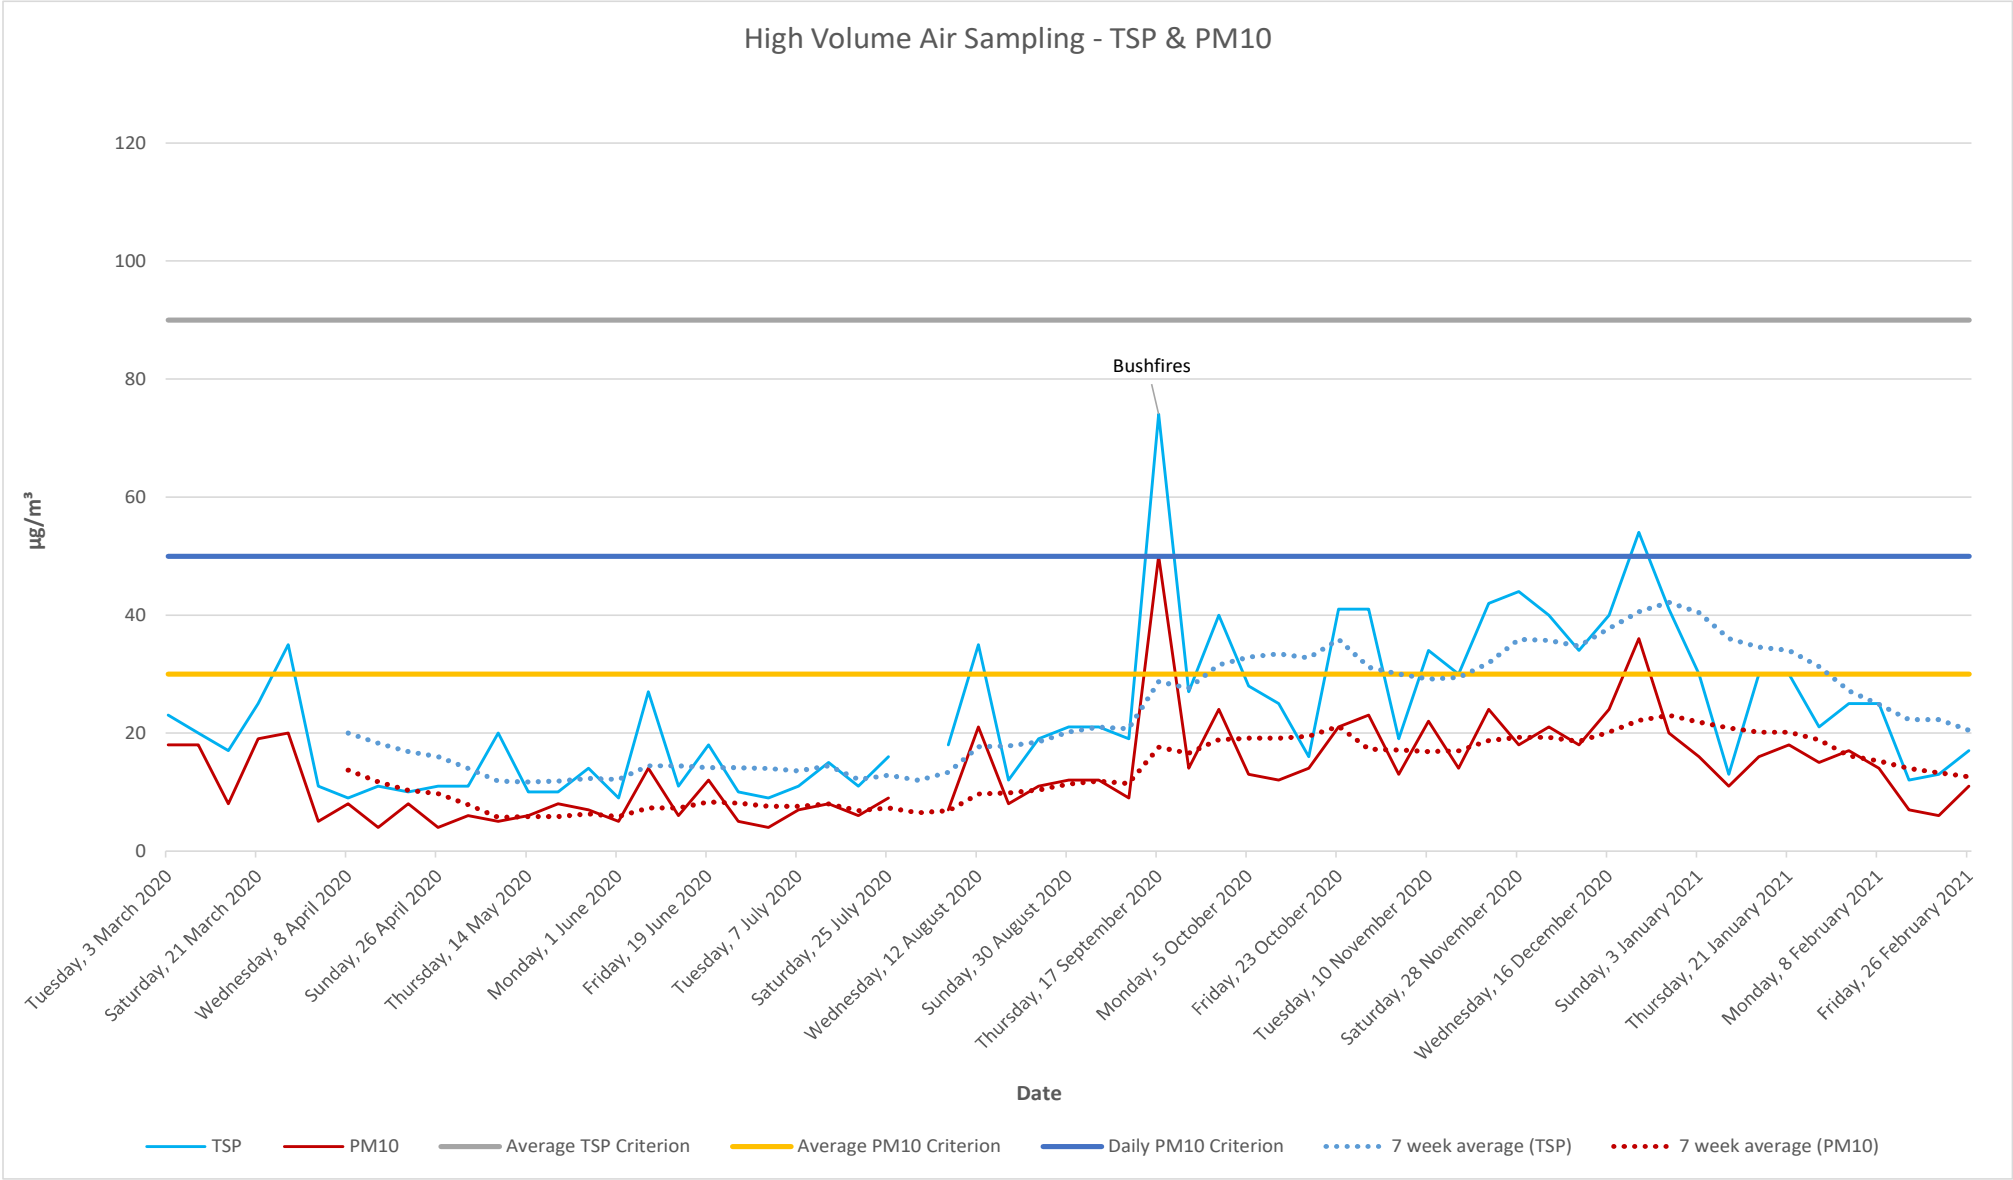
Figure 1 High Volume Air Sampling: Year-to-date results

The TSP and PM₁₀ results for February 2021, the report average and a rolling annual average are shown in are shown in Table 8. Figure 1 illustrates the year-to-date results for HVAS monitoring.

All HVAS monitoring results, to the end of February 2021 were compliant with the long term and short term impact assessment criteria outlined in *Schedule 3 Condition 13* of the Consent (see Table 3, Table 4 and Table 5).
