# **Karuah East Quarry**

## **Monthly Environmental Monitoring Report**

**April 2018**

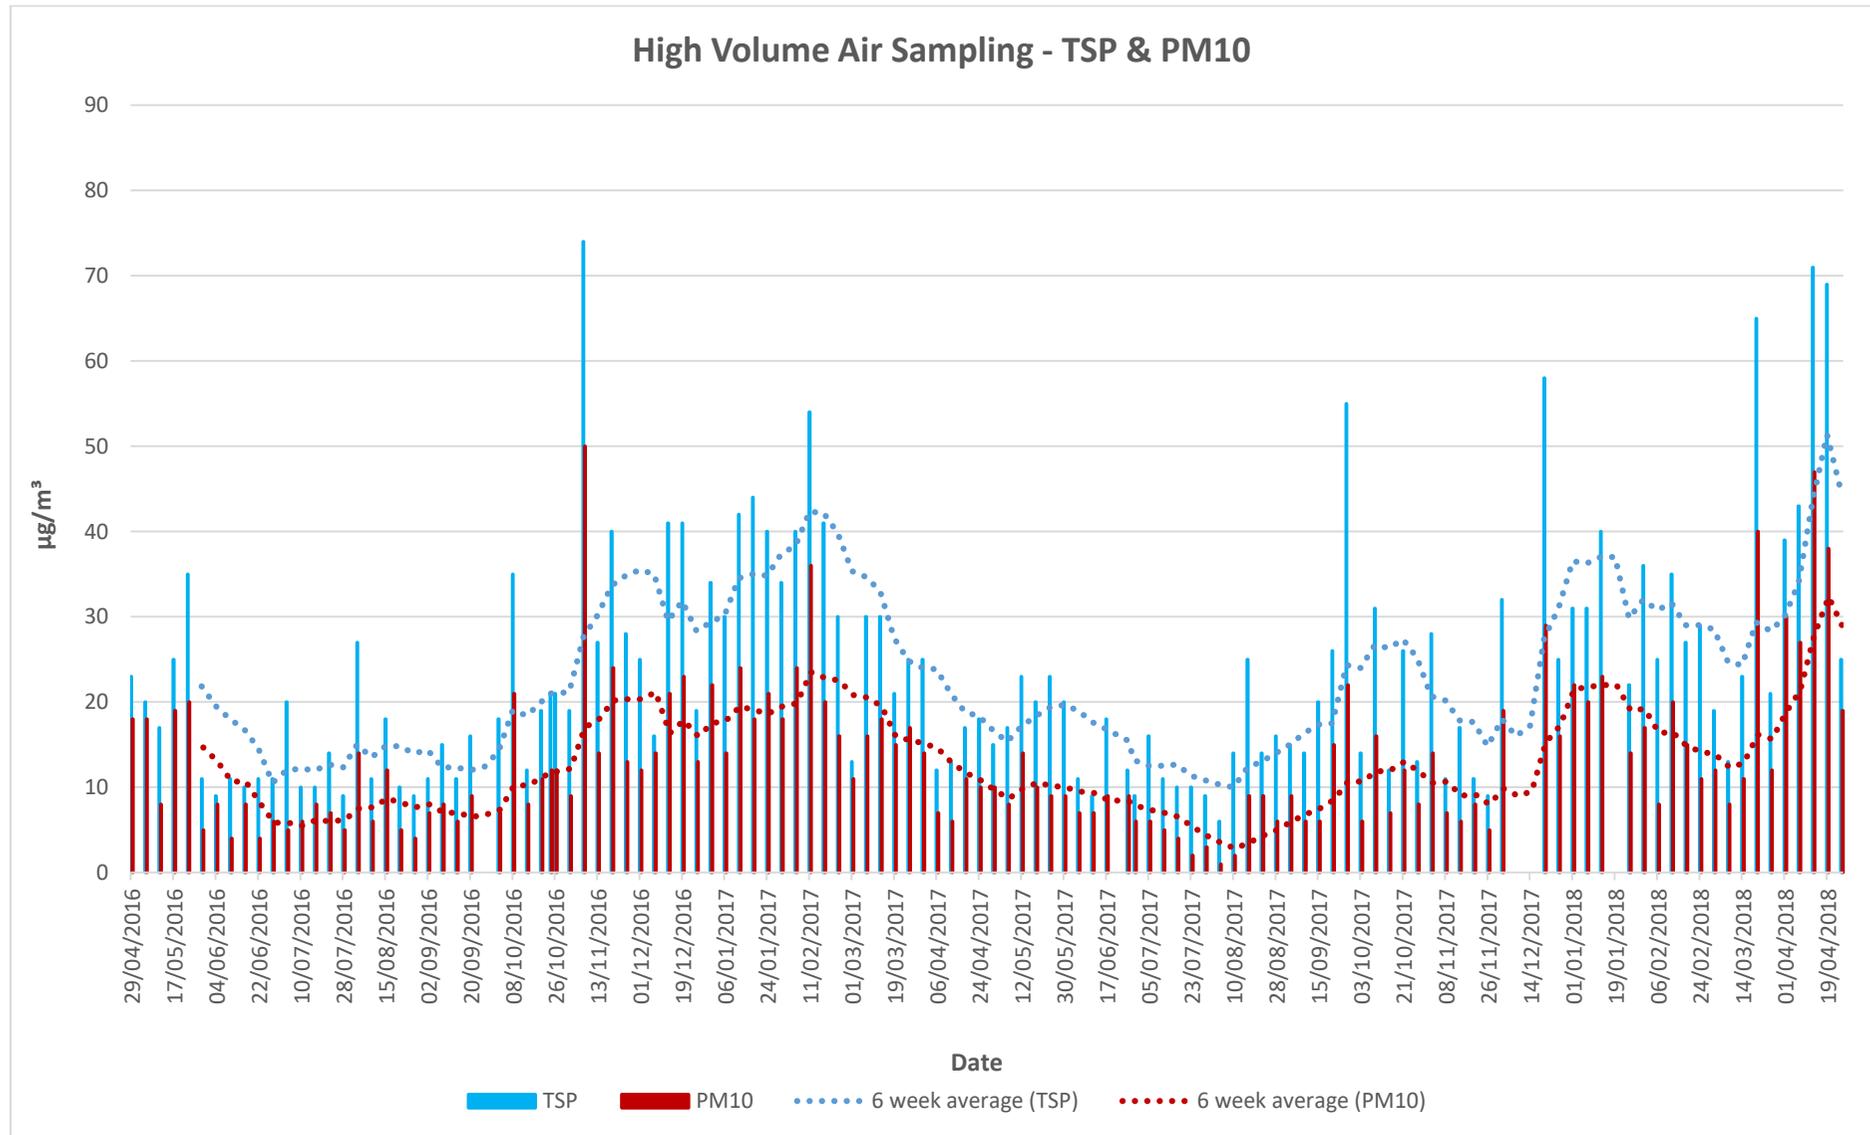
Figure 1 High Volume Air Sampling, long term results

The TSP and PM10 results for April 2018 are shown in **Table 7** with the long term monitoring results displayed in **Figure 1**.

All dust monitoring results to the end of April 2018 indicate that the Dust Deposition (Insoluble Solids), TSP and PM10 levels recorded were below the project criterion.
