Karuah East Quarry

Monthly Environmental Monitoring Report

June 2018

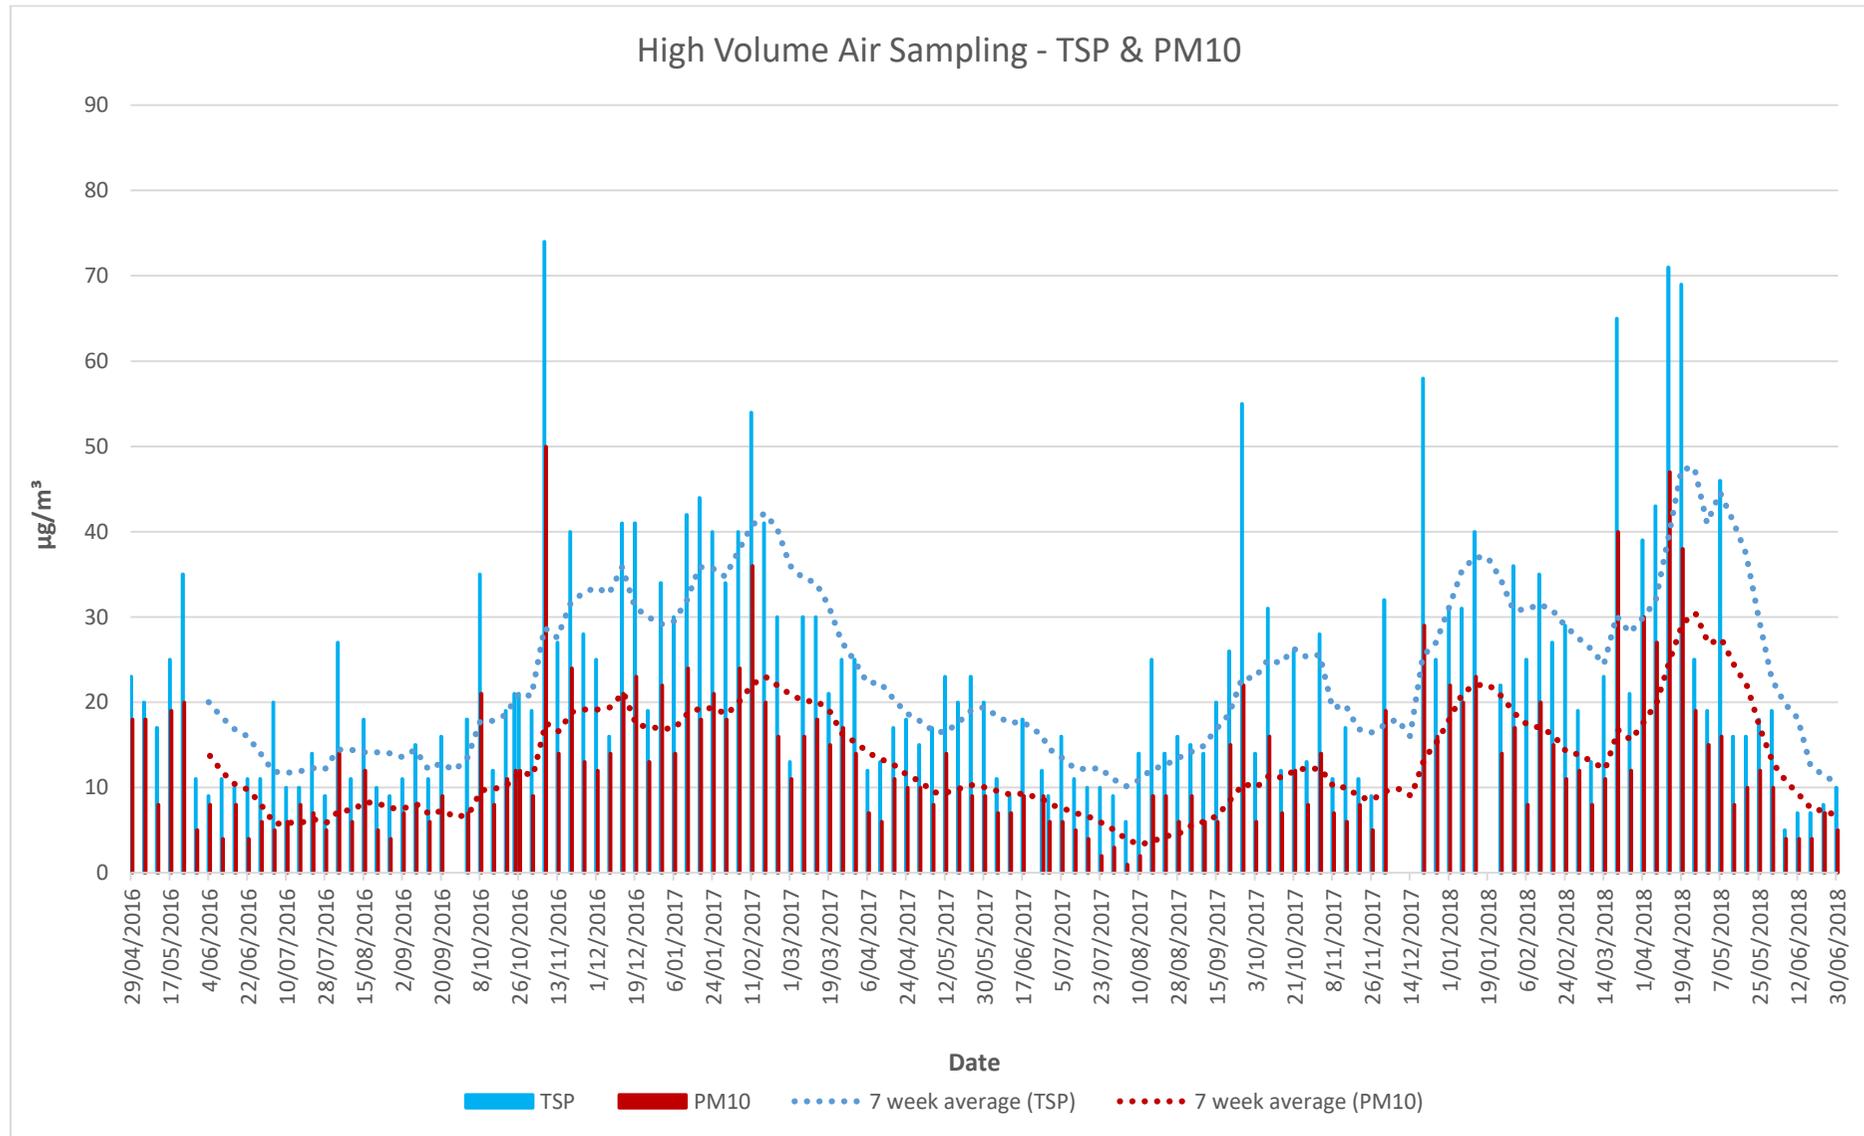
Figure 1 High Volume Air Sampling – Long term results

The TSP and PM10 results for June 2018 are shown in **Table 7** with the long term monitoring results displayed in **Figure 1**.

All dust monitoring results to the end of June 2018 indicate that the Dust Deposition (Insoluble Solids), TSP and PM10 levels recorded were below the project criterion. The average TSP and PM10 results were the lowest for any month since records commenced in April 2016.

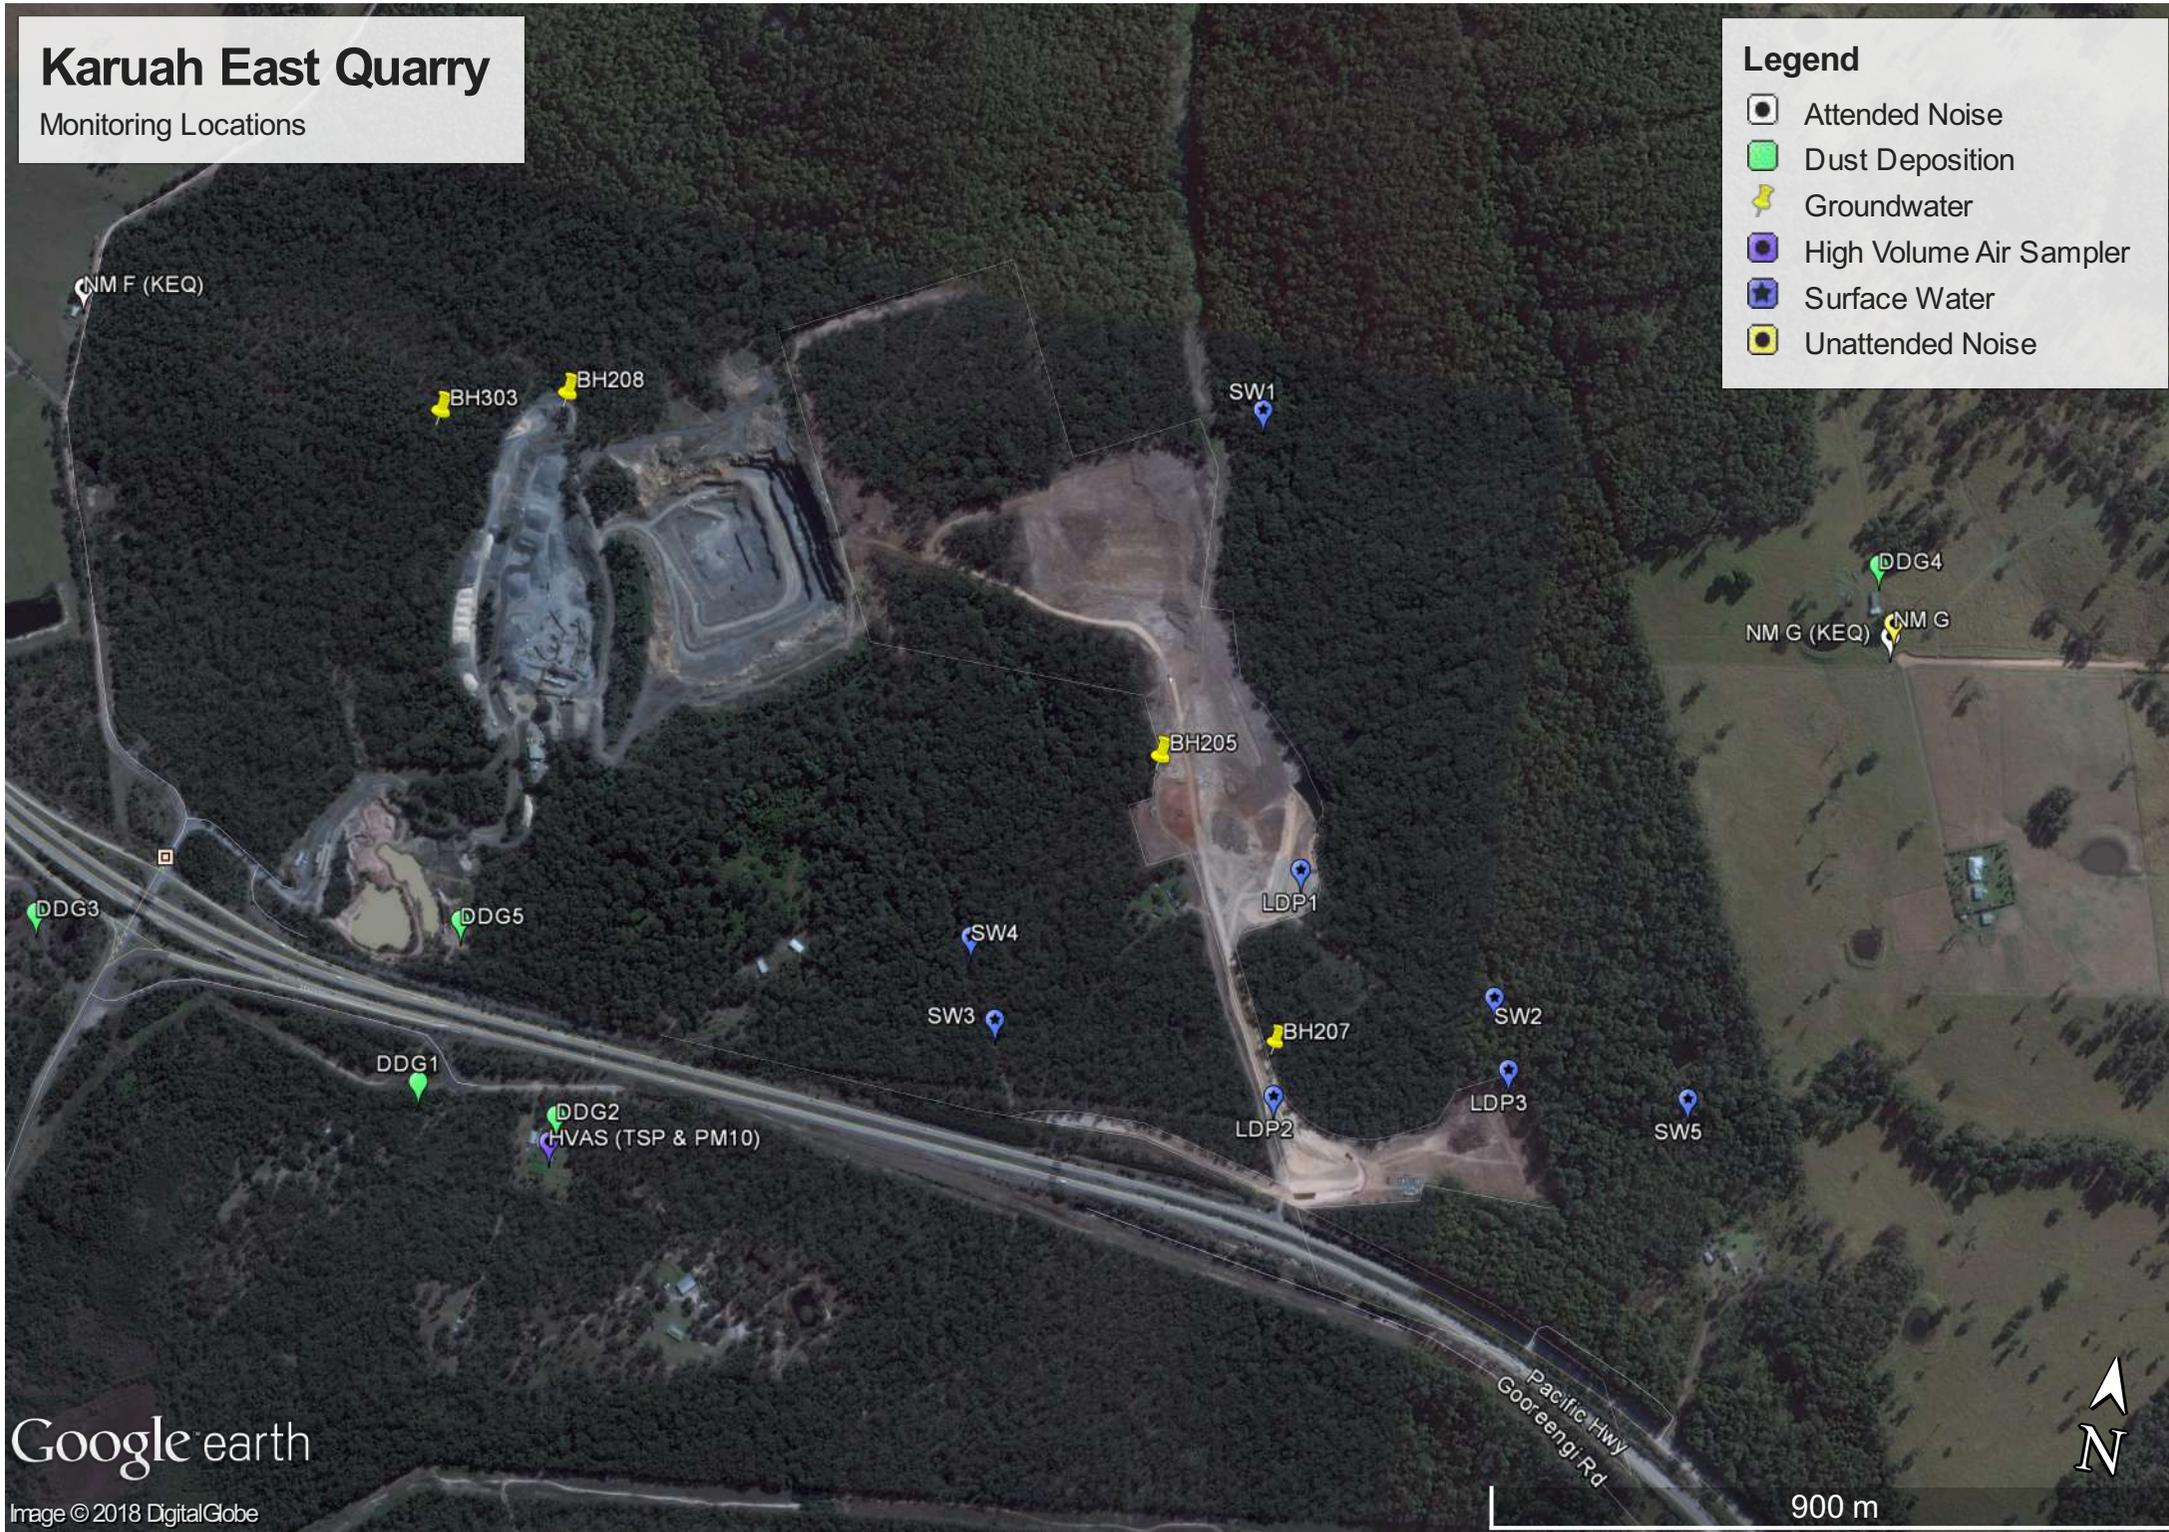
Monitoring Locations

- Attended Noise
- Dust Deposition
- Groundwater
- High Volume Air Sampler
- Surface Water
- Unattended Noise

- Note:**
1. Monitoring locations are shown in Appendix 1.
 2. Criteria is for daytime limits. Daytime is defined as the period from 7am to 6pm Monday to Saturday and 8am to 6pm Sunday and Public Holidays.

Groundwater monitoring is undertaken to meet the *EA Statement of Commitments* (Appendix 6, PA 09_0175) and Section 8.2 [Water Management Plan \(SLR, 2015\)](#). Groundwater levels are monitored quarterly and water quality biannually at four groundwater monitoring bores (piezometers). Details of this monitoring program is shown in **Table 17**. Refer to Appendix 1 for piezometer locations.
