# **Karuah East Quarry**

## **Monthly Environmental Monitoring Report**

**August 2018**

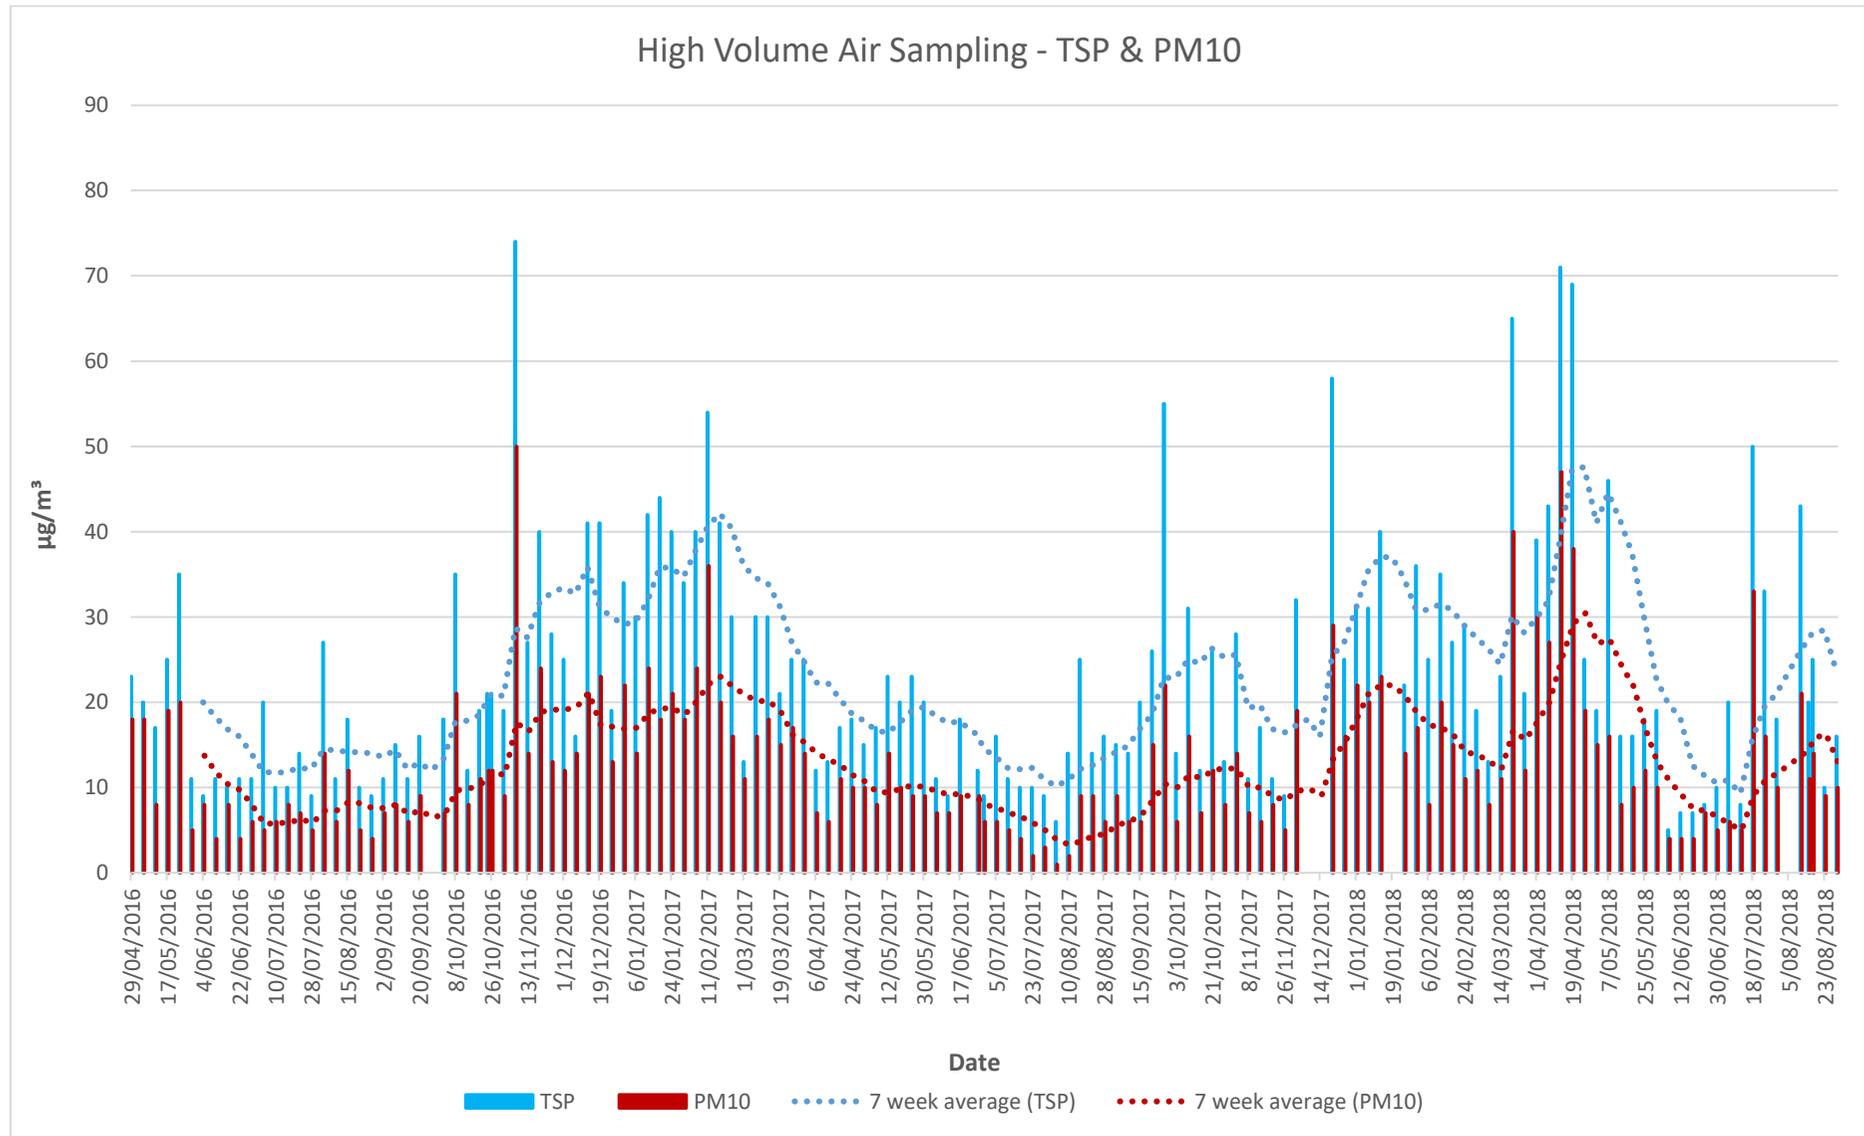
Figure 1 High Volume Air Sampling – Long term results

The TSP and PM10 results for August 2018 are shown in **Table 7** with the long term monitoring results displayed in **Figure 1**.

All dust monitoring results to the end of August 2018 indicate that the Dust Deposition (Insoluble Solids), TSP and PM10 levels were below the project criterion.
