Karuah Hard Rock Quarry

Summary of Environmental Monitoring Data

For the Period: September 2019

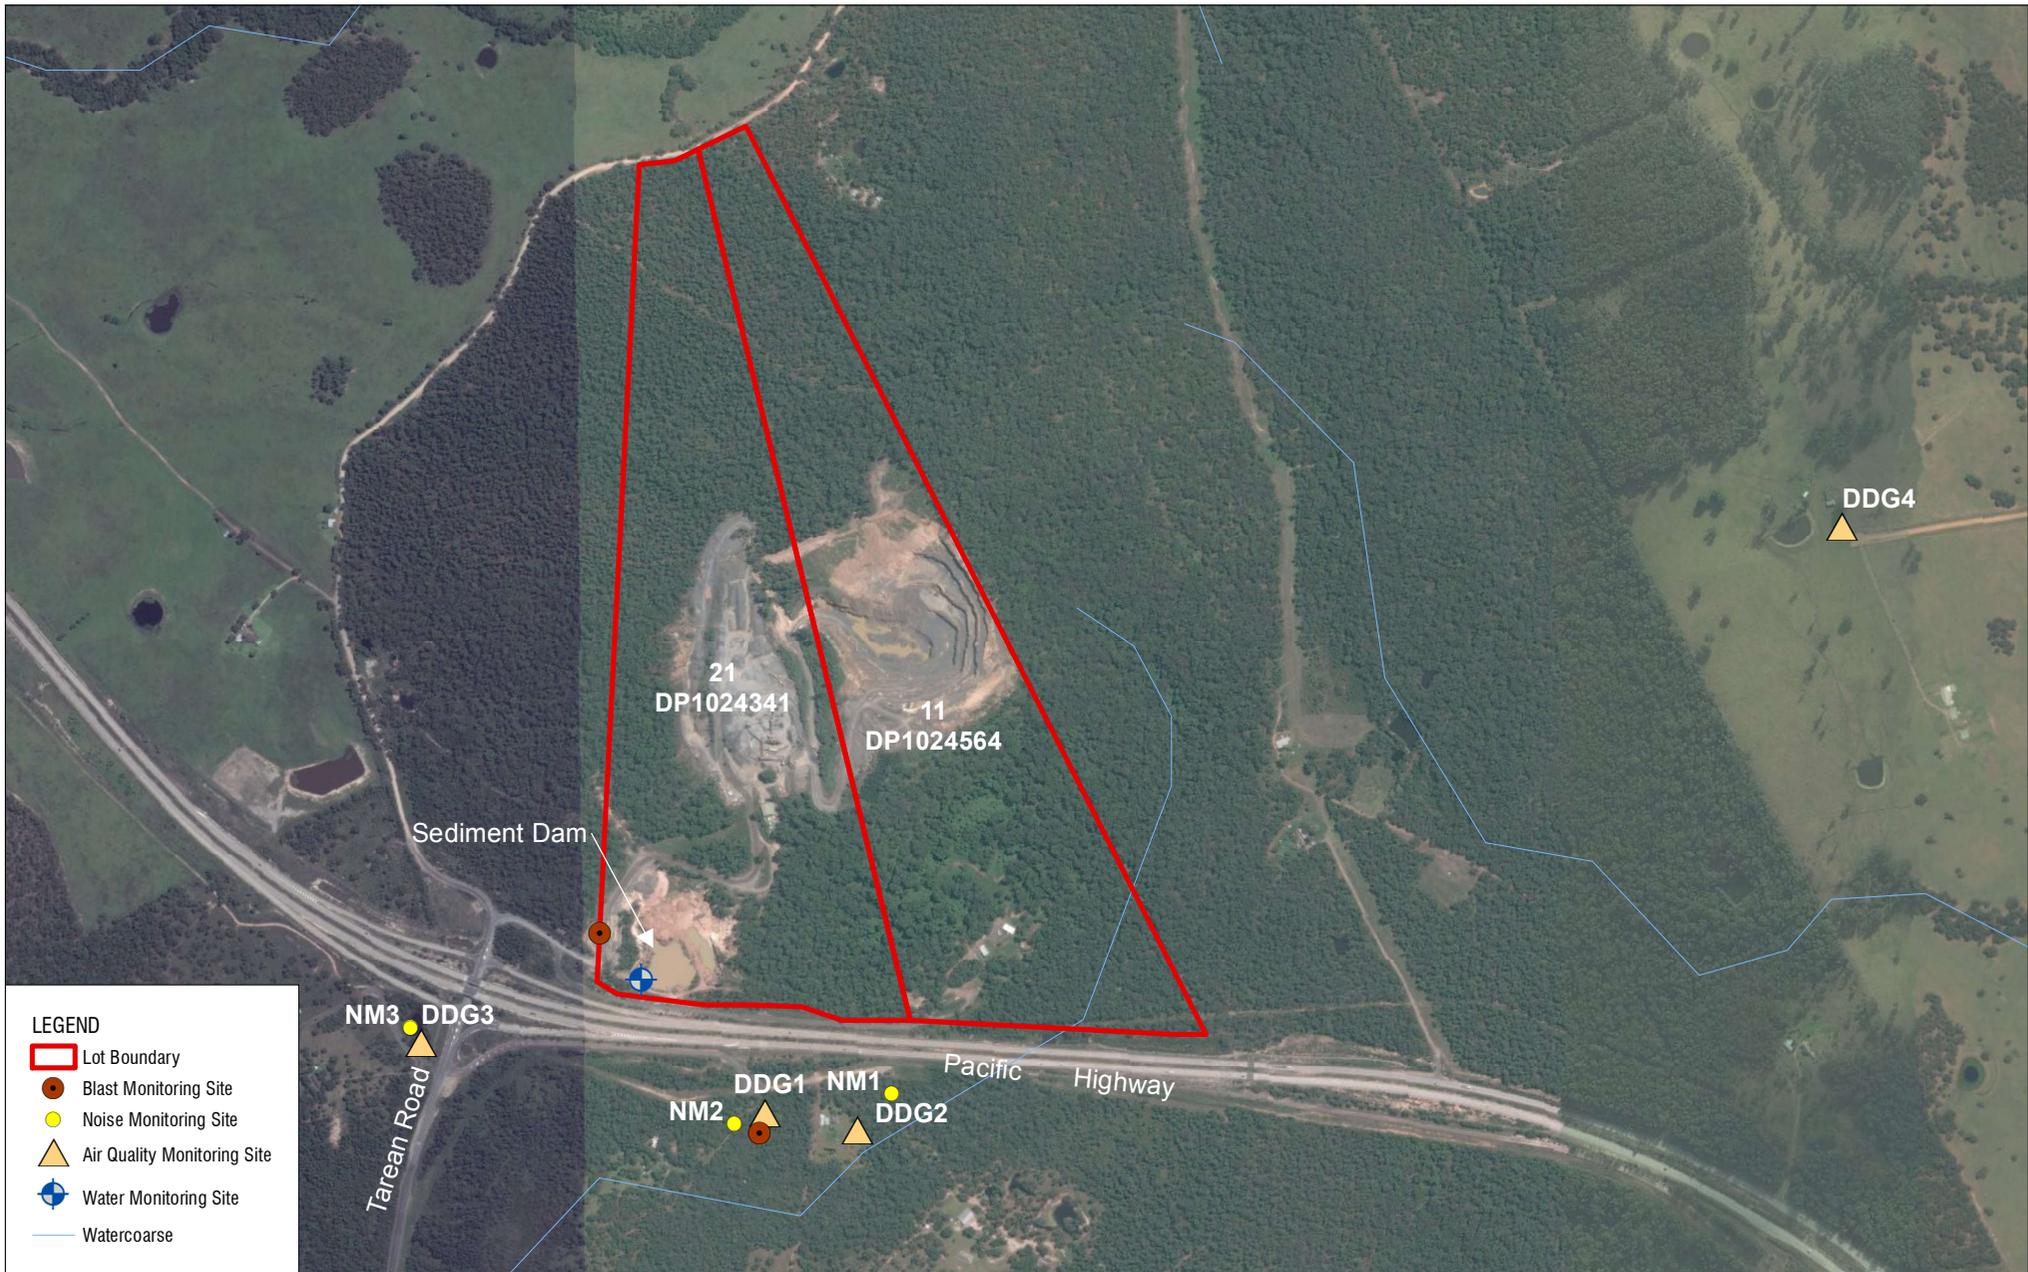
FIGURE 1

Appendix 1 Illustrates the air quality monitoring locations at Karuah Quarry.

**Karuah Hard Rock Quarry
Environmental Monitoring Locations**
