## **Karuah Hard Rock Quarry**

### **Environmental Monitoring Report:**

**June 2021**

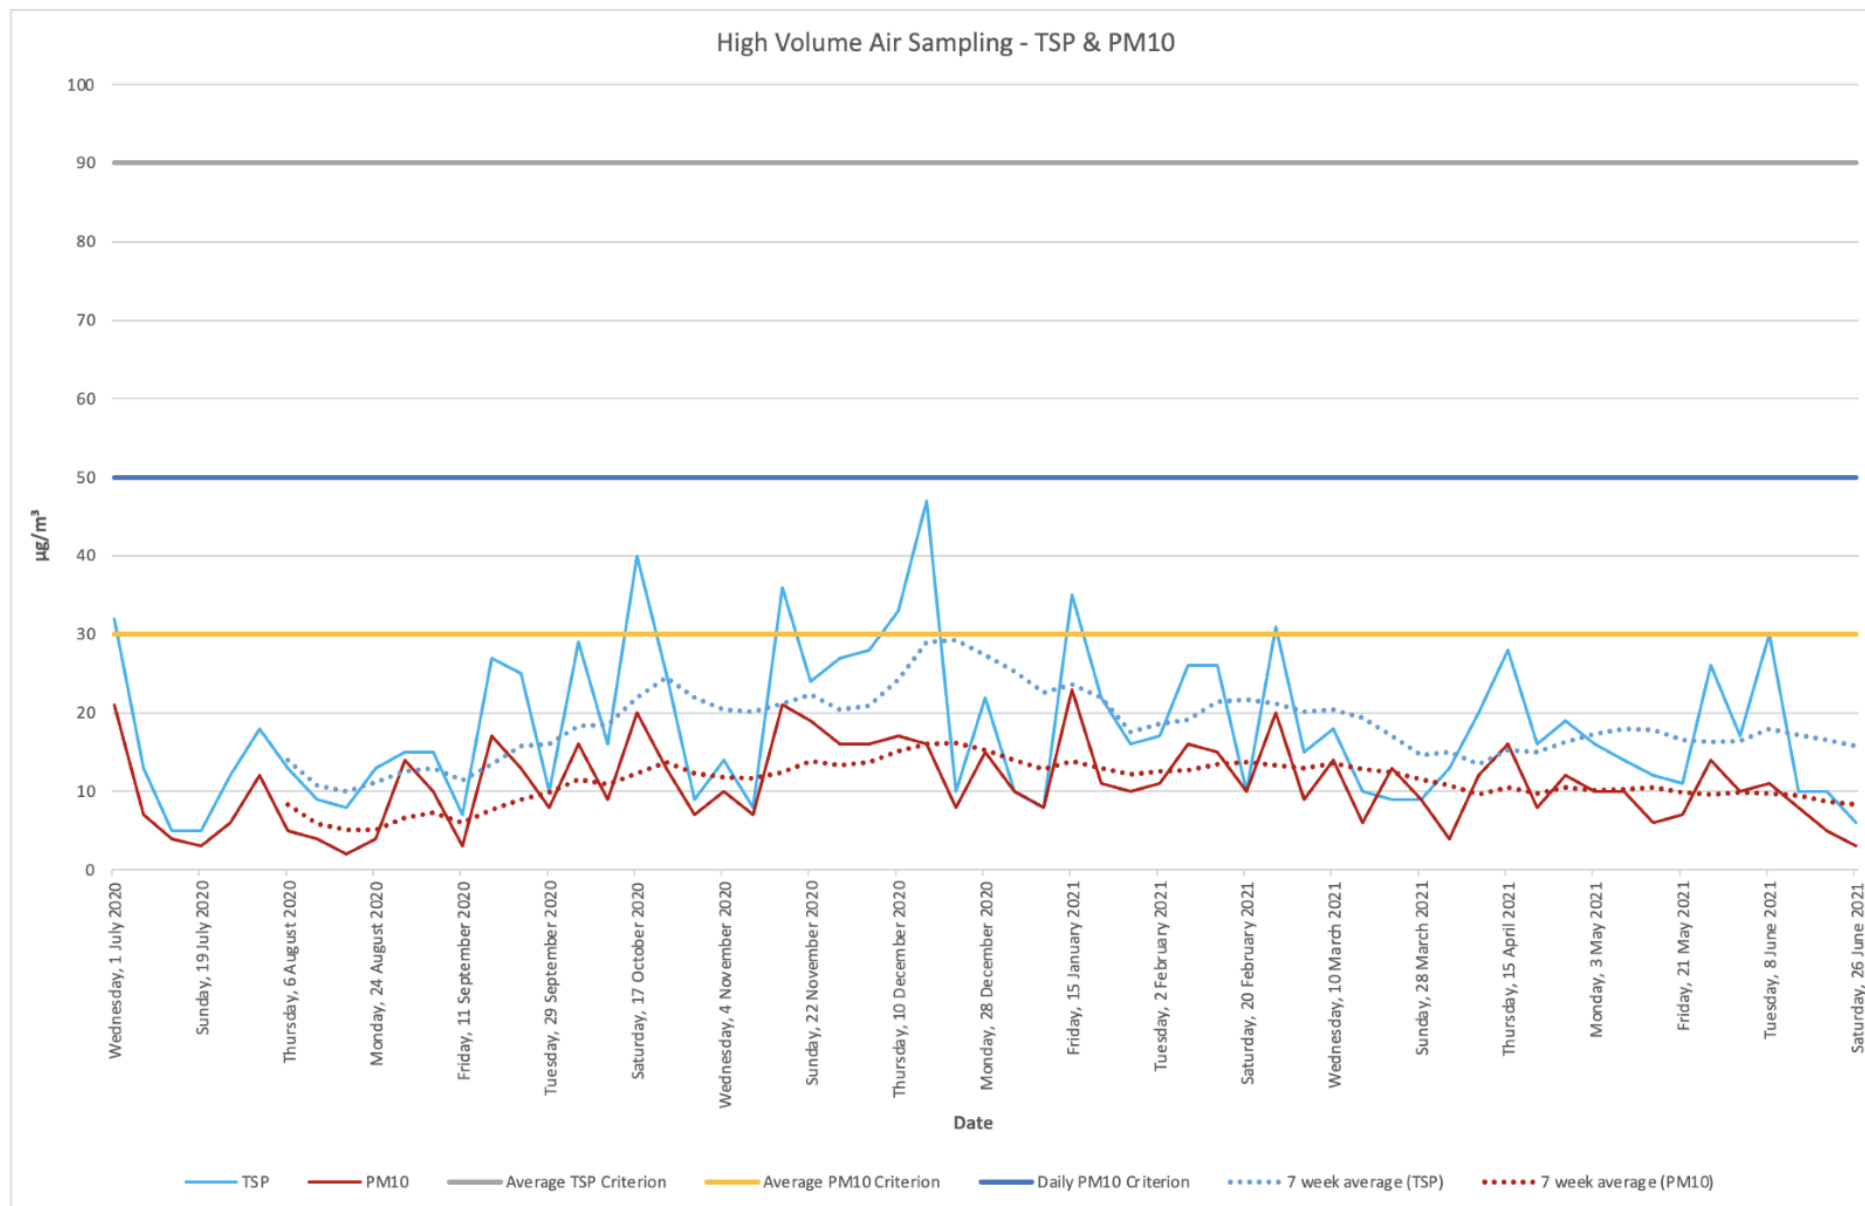
Figure 1 High Volume Air Sampling: Year-to-date results

The TSP and PM<sub>10</sub> results for June 2021, the report average and a rolling annual average are shown in are shown in Table 8. Figure 1 illustrates the year-to-date results for HVAS monitoring.

All HVAS monitoring results, to the end of June 2021 were compliant with the long term and short term impact assessment criteria outlined in *Schedule 3 Condition 13* of the Consent (see Table 3, Table 4 and Table 5).

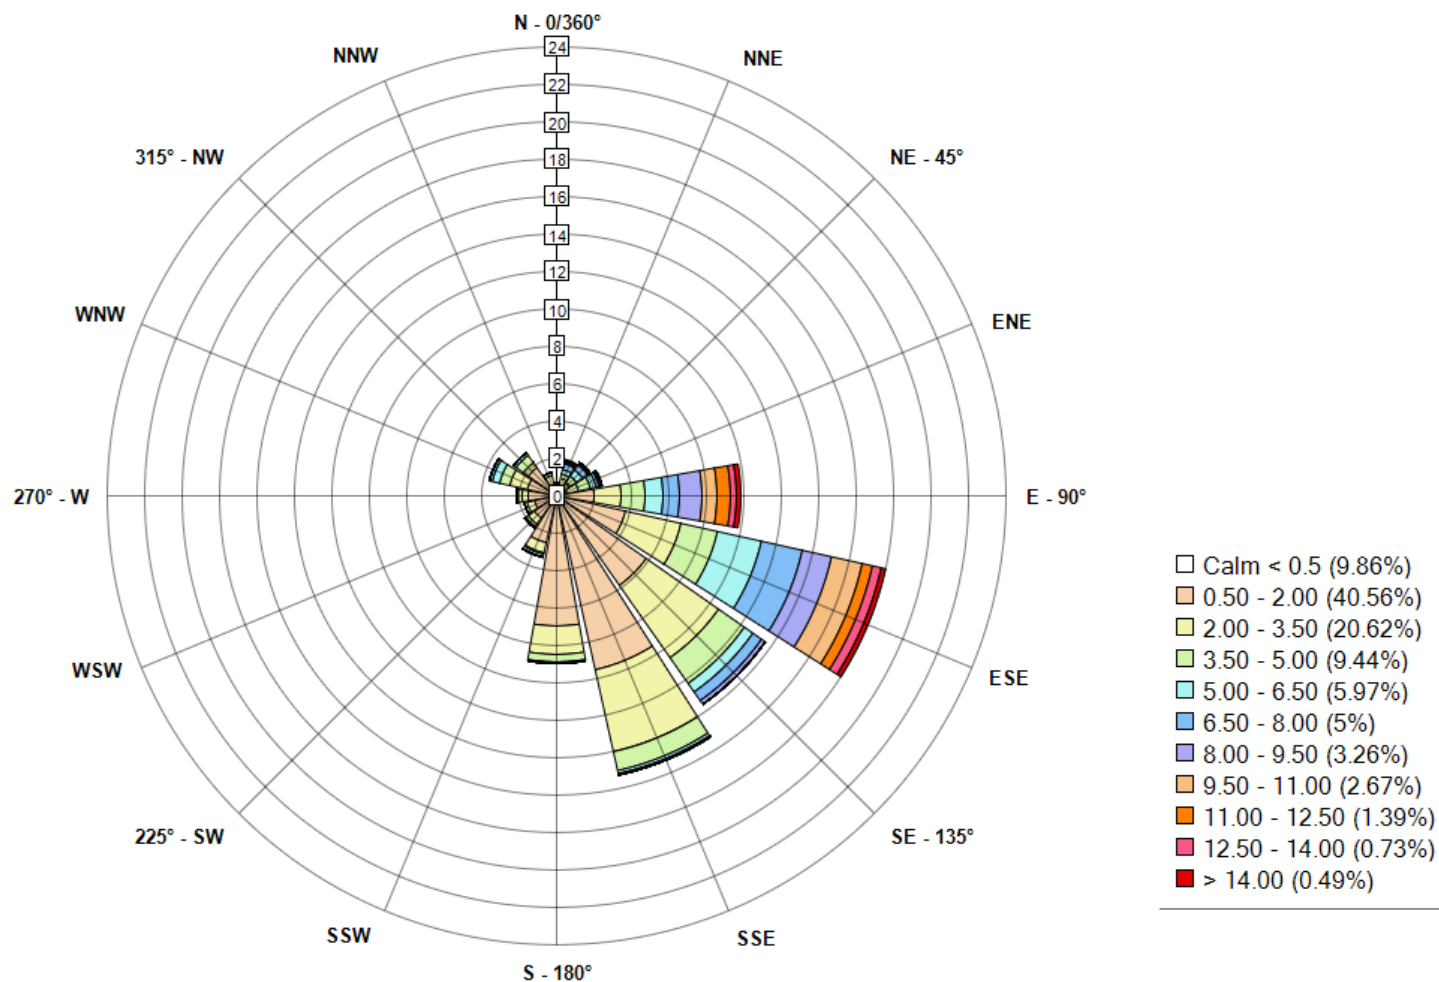
Figure 3 Wind rose June 2021

A wind rose is a graphic tool used to depict the average direction and speed of the wind over a recorded period. Figure 3 shows the wind rose generated from data gathered during June 2021.

## Wind Rose Report for: Karuah East - 15 Min Data

VWDIR Vector Wind Dir and VWSP Vector Wind Spd in km/h

Period: 2021-06-01 00:00 to 2021-06-30 23:59

Direction the Wind is Blowing To
