## **Karuah Hard Rock Quarry**

### **Environmental Monitoring Report:**

**November 2021**

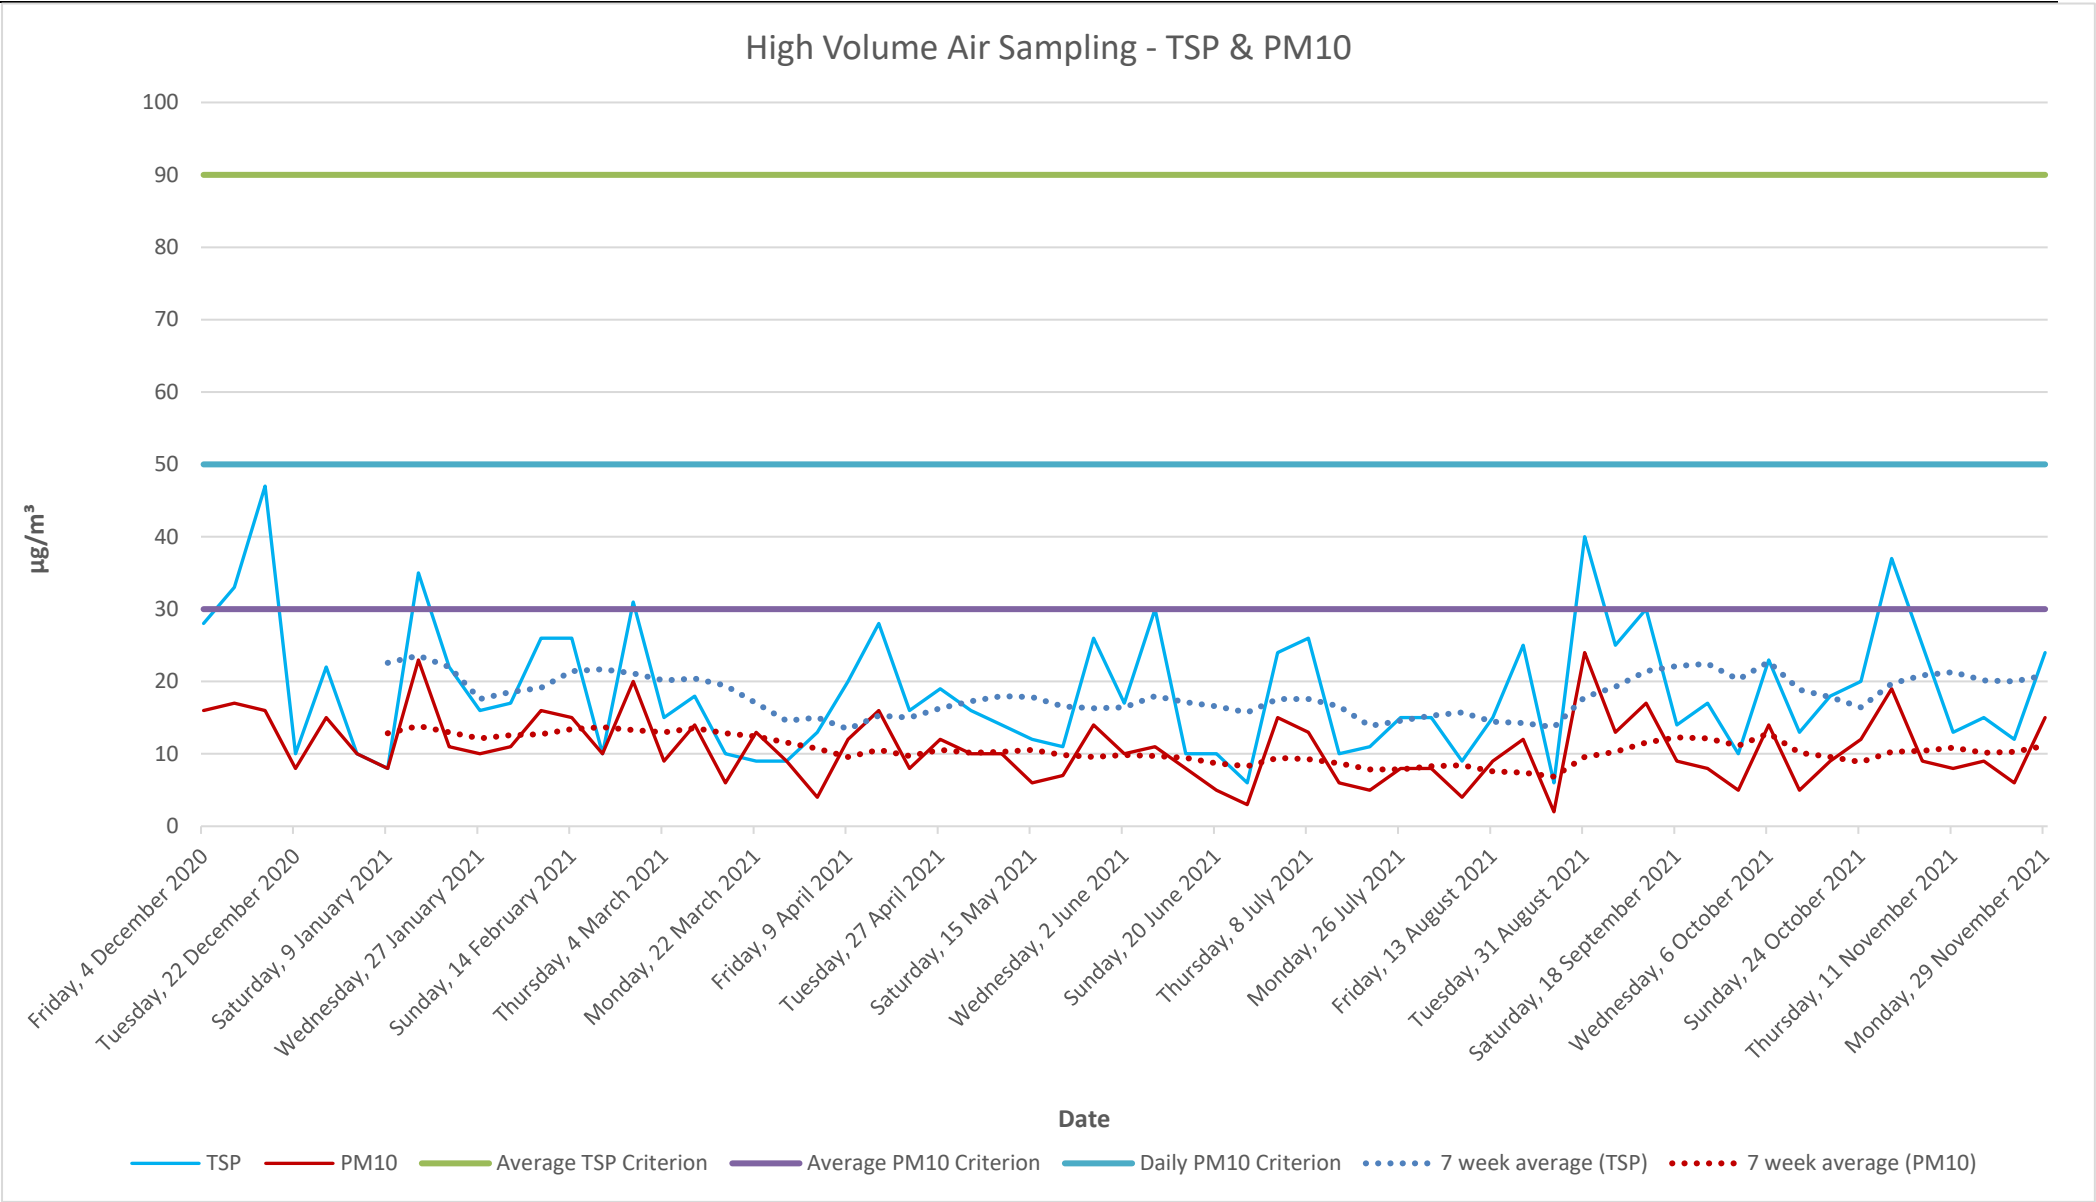
Figure 1 High Volume Air Sampling: Year-to-date results

The TSP and PM<sub>10</sub> results for November 2021, the report average and a rolling annual average are shown in are shown in Table 8. Figure 1 illustrates the year-to-date results for HVAS monitoring.

All HVAS monitoring results, to the end of November 2021 were compliant with the long term and short term impact assessment criteria outlined in *Schedule 3 Condition 13* of the Consent (see Table 3, Table 4 and Table 5).

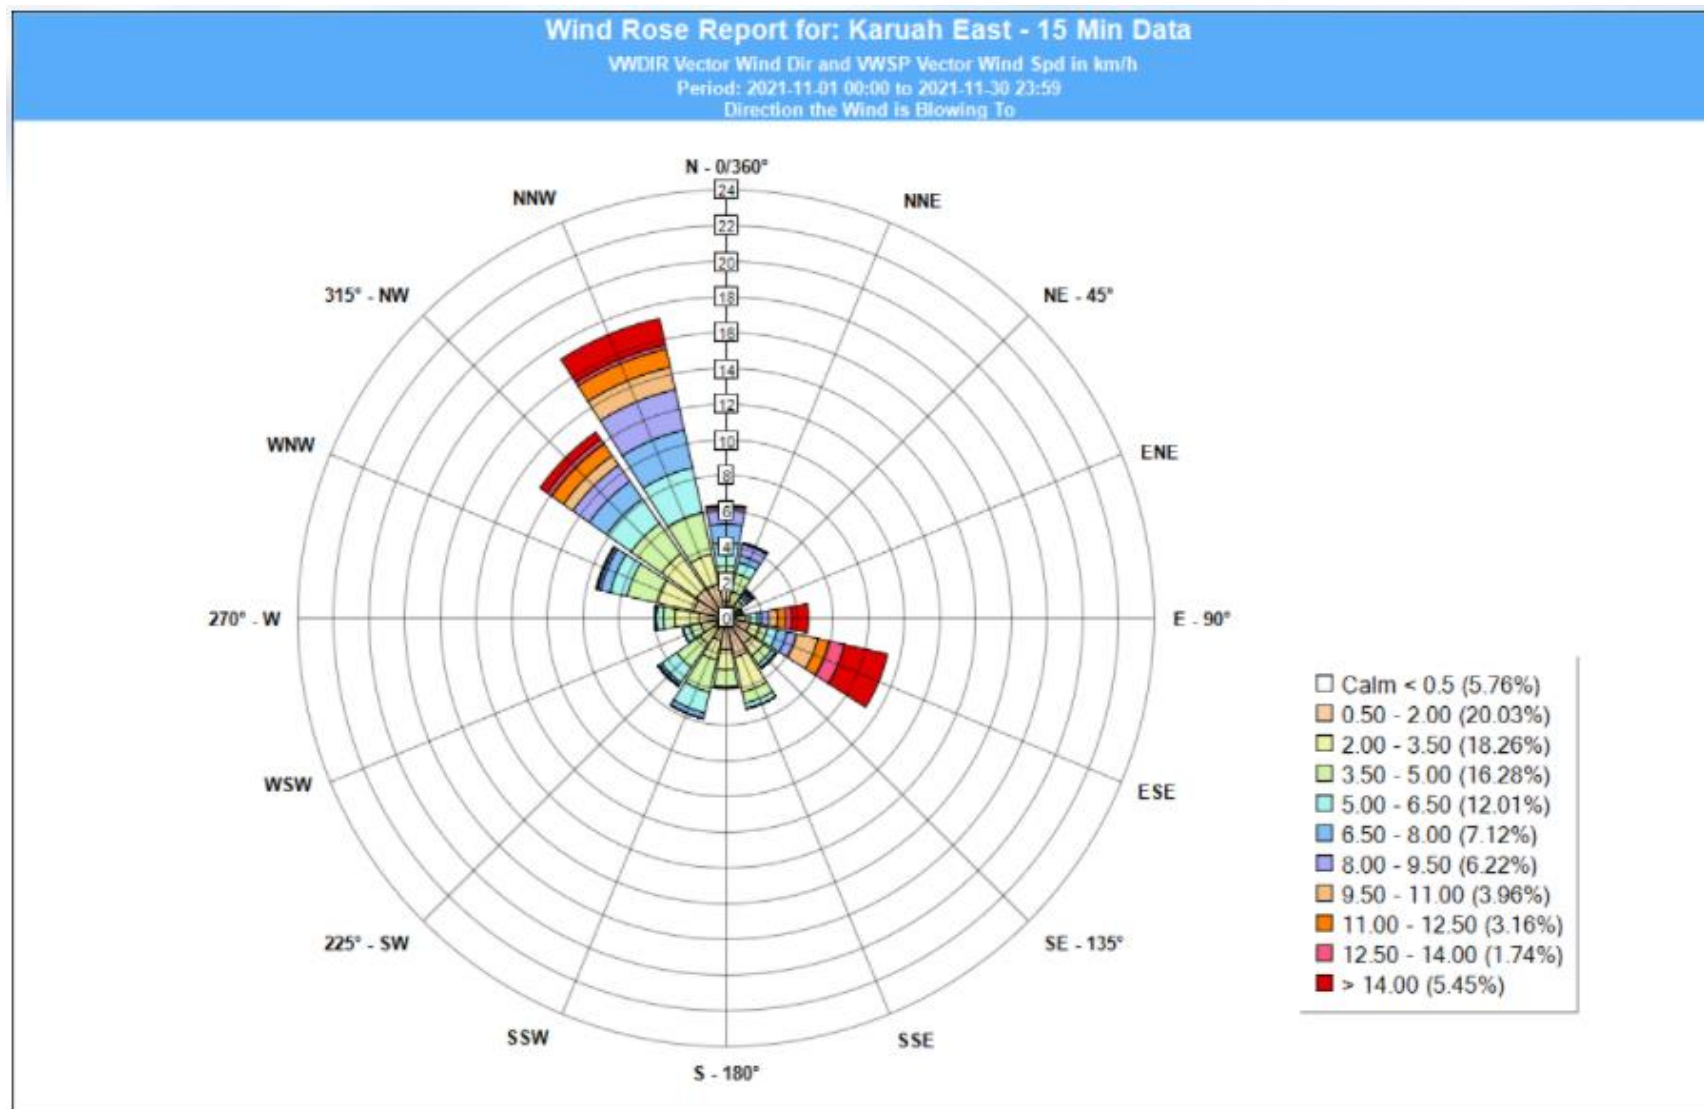
Figure 3 Wind rose November 2021

A wind rose is a graphic tool used to depict the average direction and speed of the wind over a recorded period. Figure 3 shows the wind rose generated from data gathered during November 2021.
